Overview

Premature failures in pistons, piston rings, cylinder liners, bearings and bushings

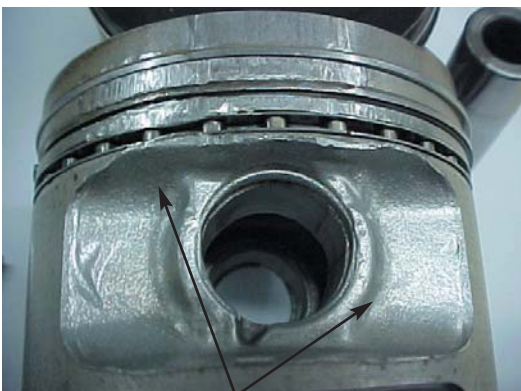
Fig. 1.1

- Breakage of the piston pin circlip groove. Generally this occurs due to a composition of forces that pushes the pin against one of the circlips, until its expulsion and/or fracture. Eventually pieces of the fractured circlip cross the inner pin diameter and damage the other end.

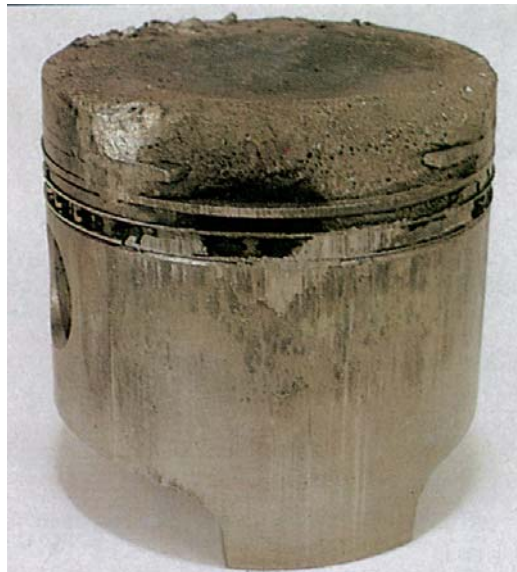
Fig. 2.2

Furthermore, it can originate in its last stages, excessive wear of the first groove, plus breakage, furrows and seizing of the piston rings.

- Use of gears and shifting, inadequate to the vehicle load and speed;
- Cylinders running at too high temperatures;
- Incorrect regulation of the carburetor (extremely poor mixture);
- Excessively advanced spark;
- Low quality fuel (with low octane content);
- Incorrect distributor calibration/regulation;

- Periodical revision of fuel and ignition systems, maintaining them in working conditions as recommended by the engine manufacturer;
- Avoid engine overloading.

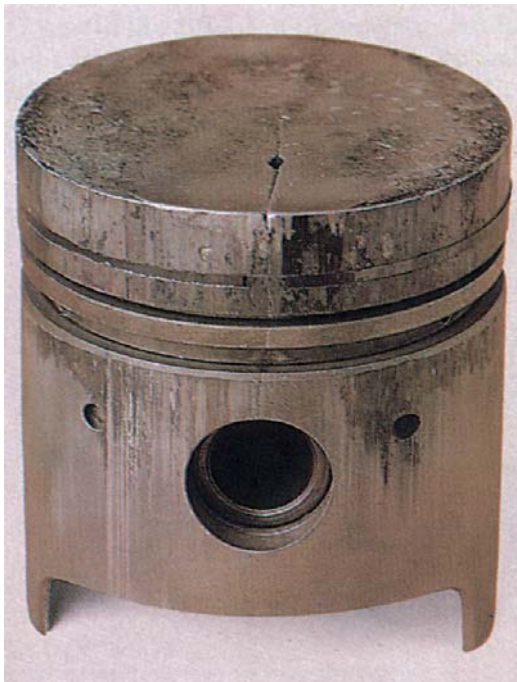
Fig. 2.4

- Cracks on piston crown;

- Cracks on upper part of the pin bosses.

- The cracks formed at the piston crown are a consequence of extreme thermal tensions. Should the cracks have been formed in perpendicular direction to the piston pin axis, in addition to the thermal effects, there have occurred also mechanical stresses, subjecting the piston to traction or compression of the crown's surface;
- If the cracks have been originated at the upper part of the bosses, and from there followed in the direction of the top, tending to part the piston in two, there has been an interaction between the boss and the piston pin. High tensions have occurred, above the recommended values, caused by compression, by deformation of the piston pin and by the wedge effect applied to the surface of the pinhole.

- The engine reconditioning, the regulation of the injection system, as well as de engine running conditions have to be performed according to the specifications given by the engine manufacturer.

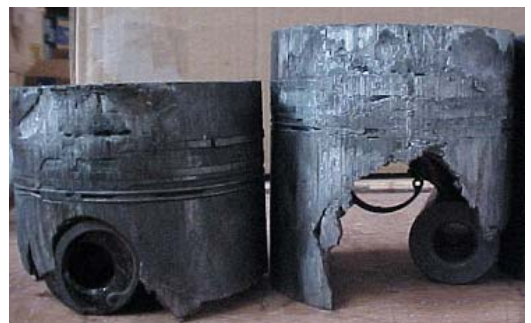
Fig. 2.6.7 Scuffing started at the top land, followed by rupture at the pin boss

- Revise periodically injection pump and nozzles, according to recommendations given by the engine manufacturer.

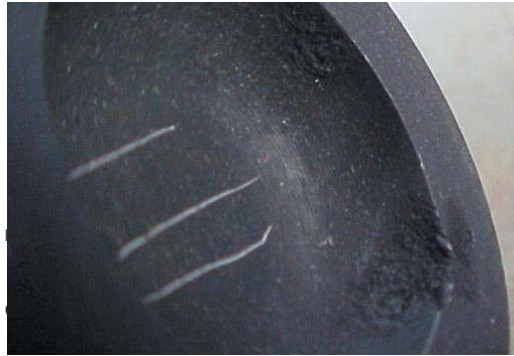
- Excessive fuel injection at each cycle;
- Premature injection (anticipated ignition point);
- Incorrect spraying;
- Leaky injectors nozzle.

Fig. 2.7.2 Partial destruction of the combustion chamber

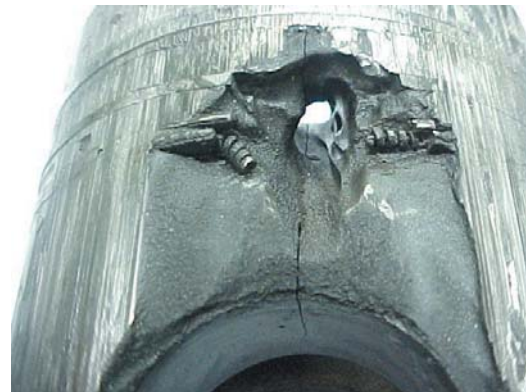
Fig. 2.7.11 Destruction of the crown and the pin boss region, due to irregular function of injection nozzle

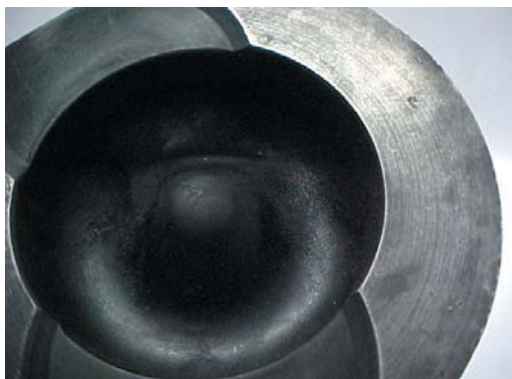
Fig. 2.13.1 Machining marks at piston crown

- Use pistons with lower compression height, if available;
- Replace the engine block.

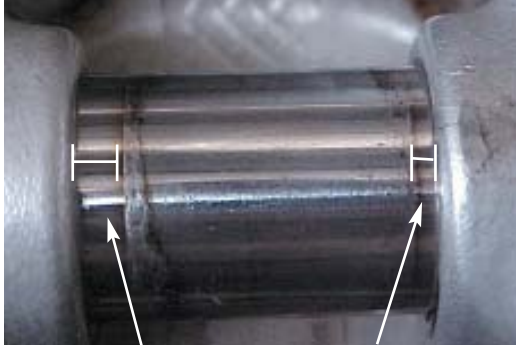
- Incorrect position of the con rod in relation to the piston pin;
- Irregular heating of the con rod during fitting process.

Fig. 2.14 Eccentricity between the con rod and the piston pin

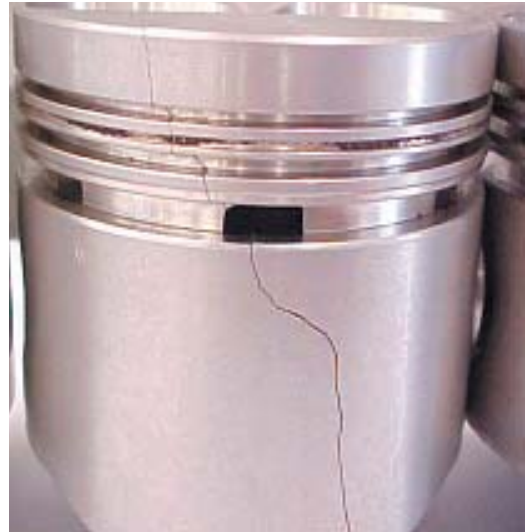
Fig. 2.14.3 Part which has been cracked during con rod fitting

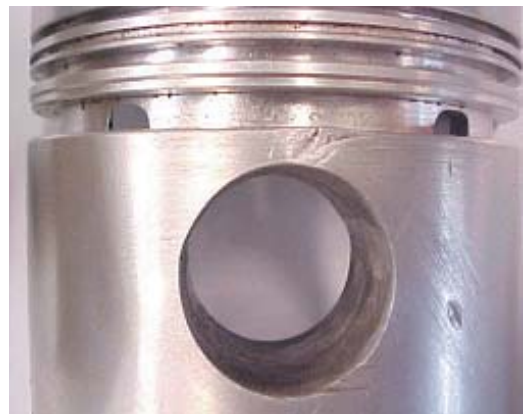
Fig. 2.14.4 Irregular mark, close to the pin boss

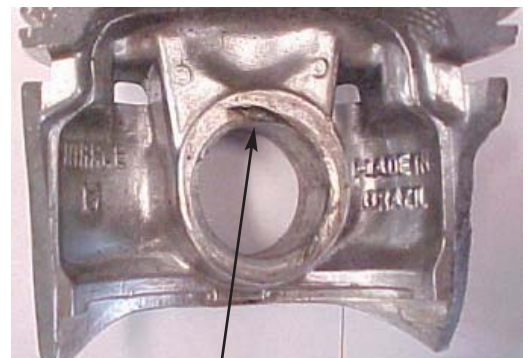
Fig. 2.14.5 Piston pin mark on the pin boss

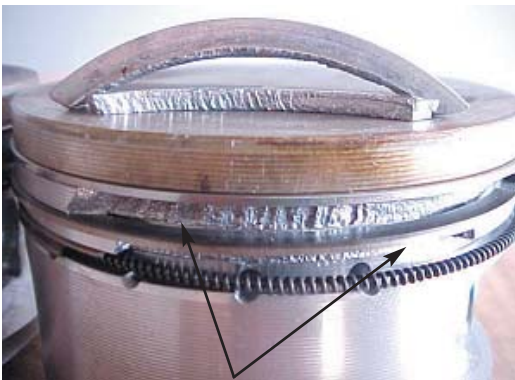
a consequence of a sudden combustion pressure peak. This occurs due to the an increase in admitted fuel volume/mass, due to the decrease in combustion chamber volume in the cylinder head and also due to an incorrect injection/ignition point. Under these conditions the piston is submitted to an increase in mechanical and thermal loads (higher peak pressure), causing the rupture of the lands between the ring grooves. This rupture/ breakage is related to the process called "DETONATION".

Fig. 2.15 Broken lands in piston (Otto-cycle engine)

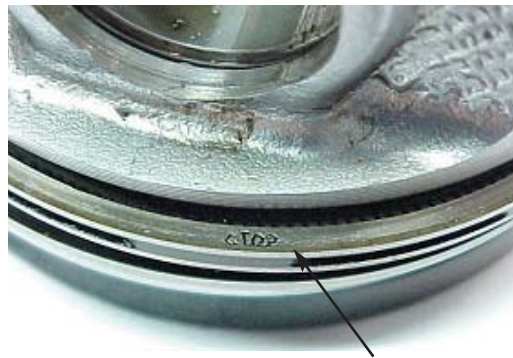
in the combustion chamber. It can also increase the lubricating oil contamination by gases, which will reduce the operational life of the lubricant and produce damages to other engine components (main and con rod bearings, and bushings).

Fig. 3.1 Piston ring mark mounted towards the lower side

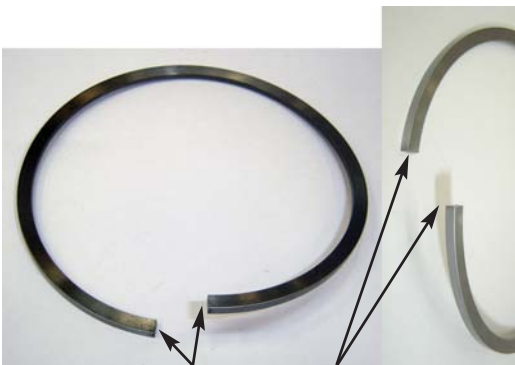
Fig. 3.4 Displaced butts due to incorrect mounting

The recommended gap opening, during the piston ring installation, shall not exceed 8,3 times the radial width of the piston ring. For example: a piston ring with radial width of 3,00 mm has a maximum gap opening allowance of $3,00 \times 8,3 = 24,90$ mm.

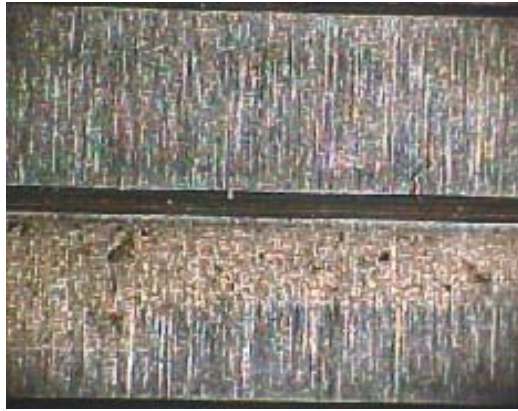
Fig. 3.5.1 Piston rings with scratches on running face

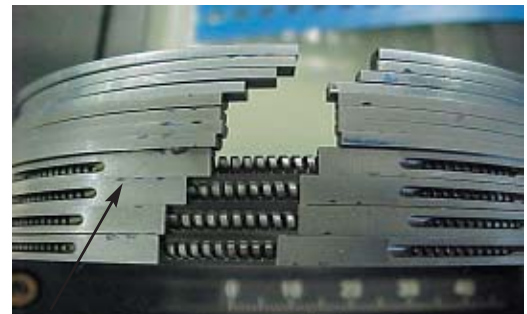
Fig. 3.5.7 Considerable wear on the third groove

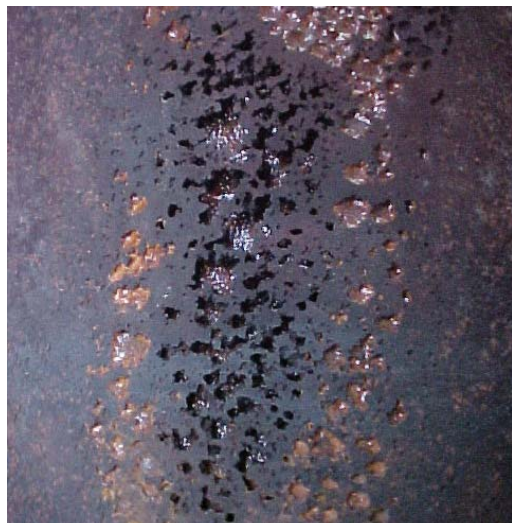
Fig. 6.1.2 Cavitation and scales

- Keep all cooling system components (reservoir and/or radiator cap, hoses and clamps, thermostatic and pressostatic valves, water pump, etc.) in normal running conditions, compatible with the engine project;
- Always use the corrosion inhibitor additives and the anti-freezing fluids, as recommended by the manufacturer/producer of the engine;
- Keep the correct water level in the reservoir and/or radiator. When there is a refilling need in the water system, follow the recommendations given by the engine manufacturer, with regard to quantity of additives to be used;
- Assemble the engine according to recommendations given by the manufacturer/producer with regard to eventual changes in pistons, injection system or any other.

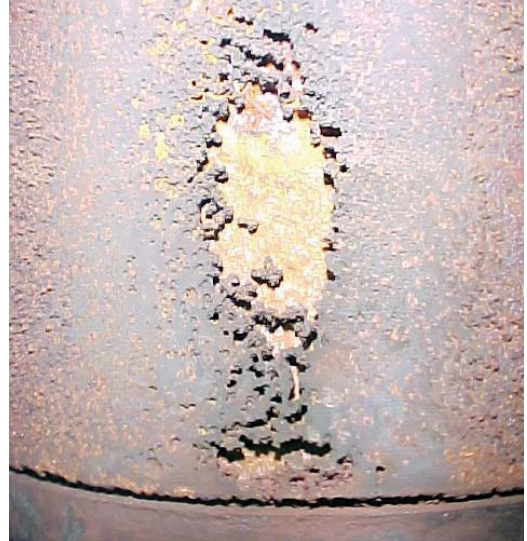
Fig. 6.1.3 Cavitation without corrosion

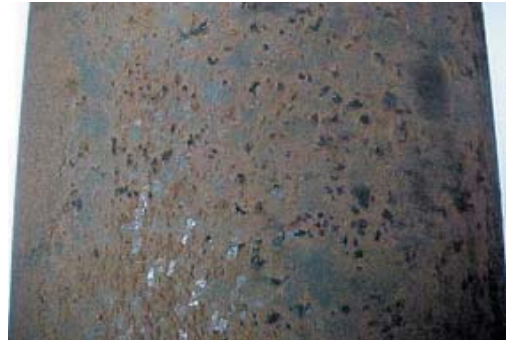
Fig. 6.1.4 Scales

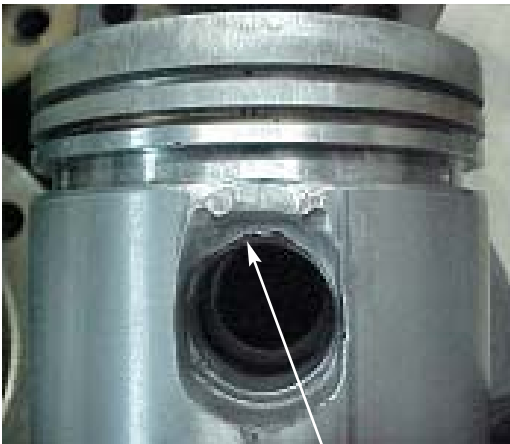
These factors cause misalignment and generate lateral forces, by which the con rod "pushes" the piston pin against the circlip. Once the circlip is expelled, the piston ring will start to move until it touches the cylinder liner. The expelled circlip, due to the vertical up-and-down piston movements, will wear the region (aluminum) until it manages to get free.

Fig. 6.2 Piston wear, at the bosses and crown region, caused by the circlip

- Keep the parallelism between the bushing housing center and the con rod bearing housing center;
- Fit the con rod according to recommendations given by the engine manufacturer;
- Install and locate correctly the circlip in its housing;
- Grinding the crankshaft and keep the journal according to the patterns recommended by the engine manufacturer.

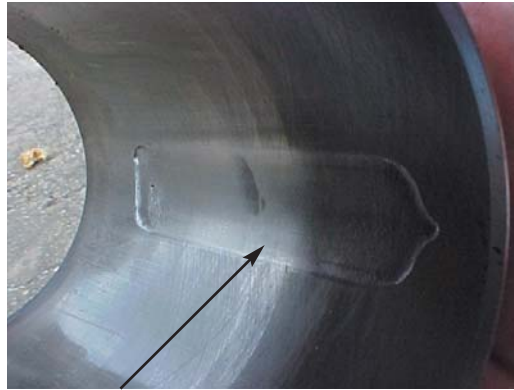
Fig. 6.2.1 Mark originated by the piston pin displacement after the circlip expulsion

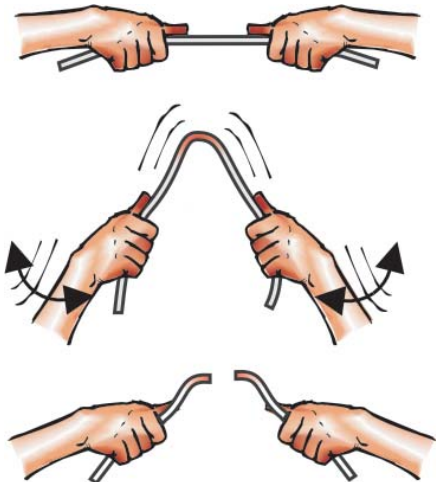
These fractures can get united to each other, which will result in bearing material detachment. One of the most common types of fatigue occurs at the upper layer of tri-metallic bearings, where the fractures, after perpendicular penetration, propagate in parallel to the nickel barrier, causing its removal in reduced areas (fig. 7.3.2).

Fig. 7.3.1 Fatigue

- If the bearing's operational life has been lower than expected, check the temperature and load conditions in which the engine has been running, and eliminate eventual existing defects;
- Avoid operational engine over-loads, observing the recommendations given by the engine manufacturer.

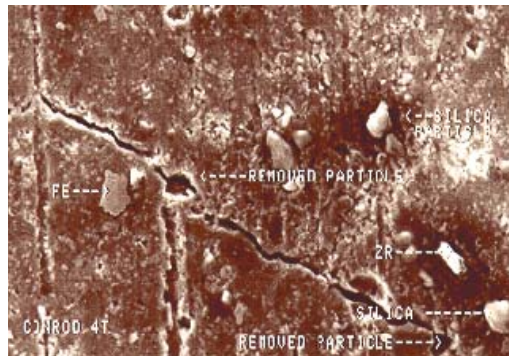
Fig. 7.3.3 Magnified 350 X

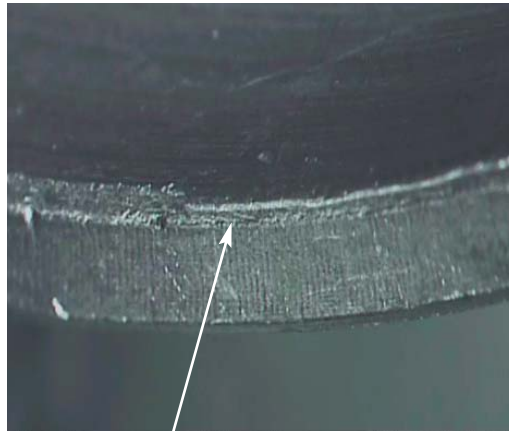
dynamic support to the axle. This results in a contact between the axle and the bearing surface, causing fusion and surface deformation of the bearing's anti-friction alloy (figs. 7.6 to 7.6.3).

Fig. 7.6 Yield of material

- Check the diametrical dimensions of bearings, con rods and crankshaft throws;
- Apply always the correct torque to the bolts and substitute them whenever recommended by the manufacturer/producer;
- Use adequate lubricating oil in your engine, as recommended by the manufacturer/producer.

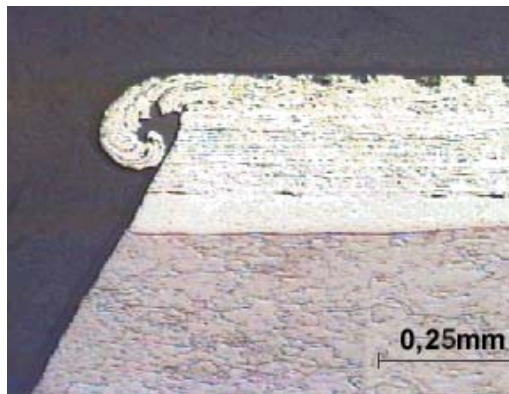
Fig. 7.6.1 Yield of material (enlarged photo)

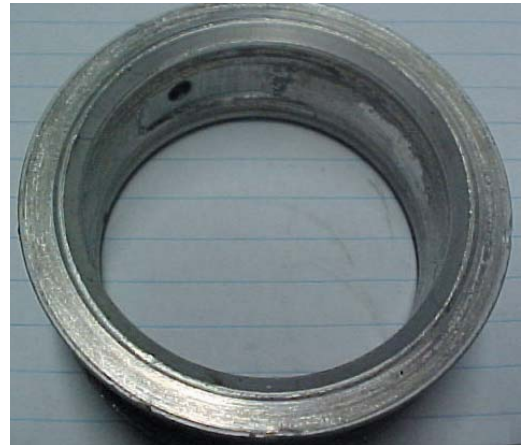
Fig. 8.1.2 Totally worn-out flange

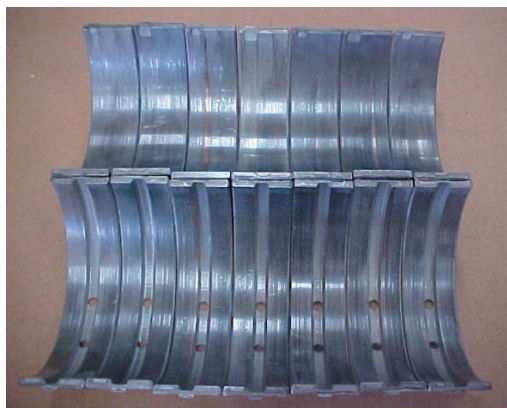
Fig. 8.2.4 Contaminated main bearings with circumferential scratches

- Install new bearings, following carefully the recommended cleaning instructions;
- Grinding the axle, if necessary;
- Recommend the operator to change periodically the oil and its filter, at the intervals specified by the engine manufacturer. Keep the air filter and the breather crankcase clean.

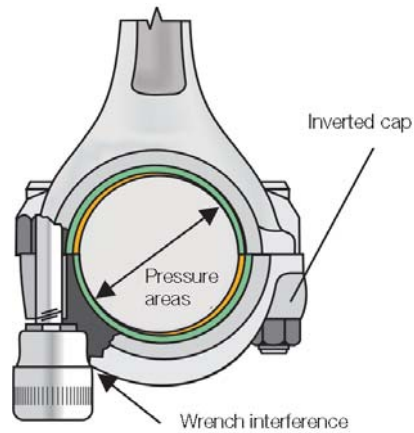
Fig. 8.8 Displaced cap

- Choose adequate wrench and fasten bolts alternatively in order to get a perfect cap seating;
- Be sure the cap position is correct;
- Check if the cap centralizing system is not altered nor damaged, and replace it, if necessary;
- Replace the con rod and/or housing bolts according to the recommendations given by the engine manufacturer;
- Machine the crankshaft according to specifications given by the engine manufacturer.

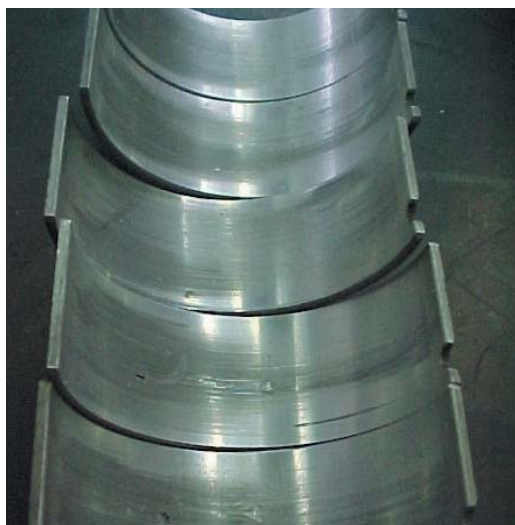
Fig. 8.8.2 Premature wear

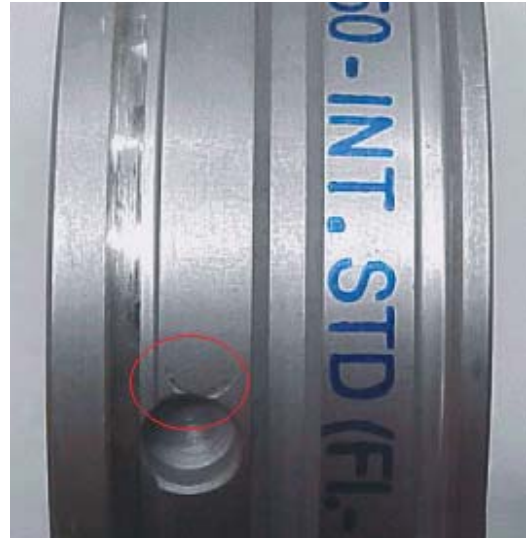
Fig. 8.13.1 Pin mark on external bearing side

- Check/revise the wrench periodically;
- Apply the torque recommended by the engine manufacturer;
- Assemble the engine according to recommendations given by the engine manufacturer, specifically with regard to the use or no-use of glue/adhesive.

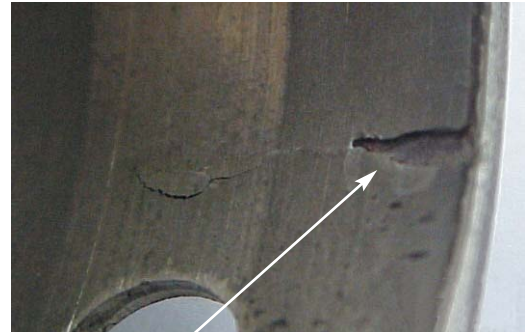
Fig. 10.2.3 Alloy detachment

- Check the housing circularity before mounting a new bushing;
- In the case of a highly deformed housing, rectify it and use bushings with external oversize;
- Keep the clearance and interference specifications between the bushing and the housing, as recommended by the engine manufacturer.

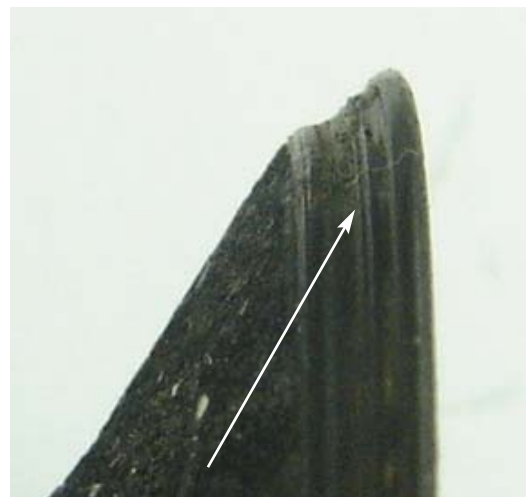
Fig. 11.2.1 Wear in the seat region

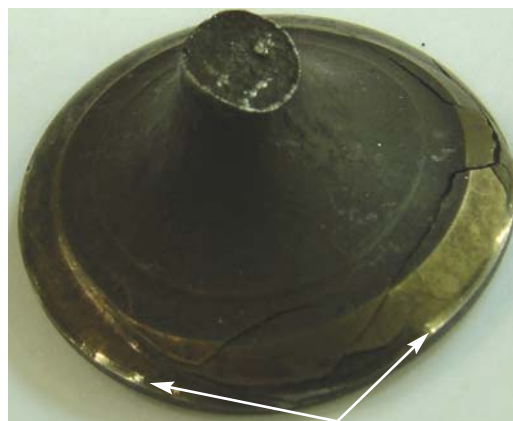
Fig. 11.3.2 Broken valve head at the radius and stem region

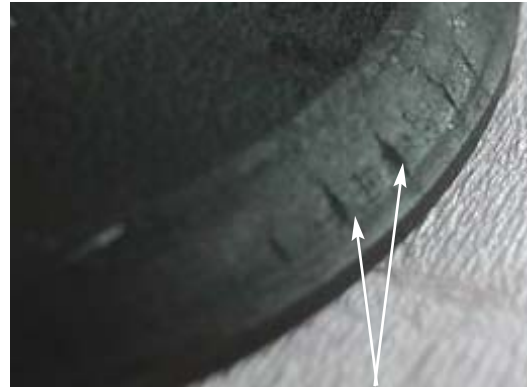
Fig. 11.5.2 Fissures on the valve seat

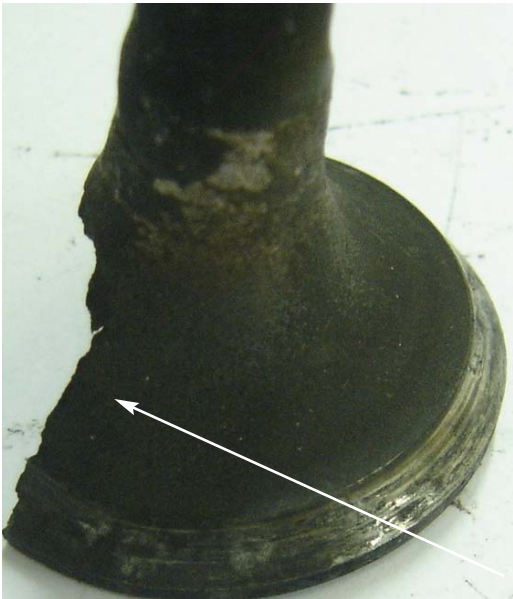
Fig. 11.6.2 Breakage of part of the head

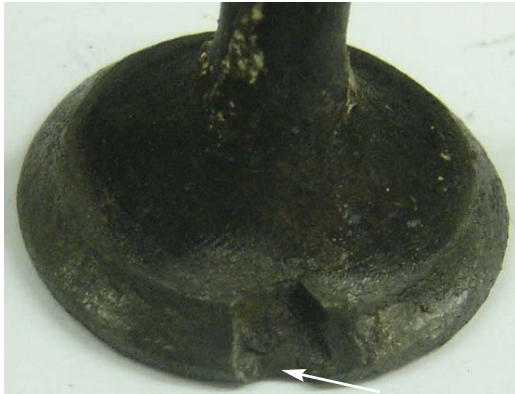
Fig. 11.8.1 Localized disintegration at the seat region

- Provide the correct seating, as well as keep the air/fuel mixture as homogeneous, and clean the cylinder head cooling galleries with products recommended by the engine manufacturer. Avoid long working cycles under idle condition.

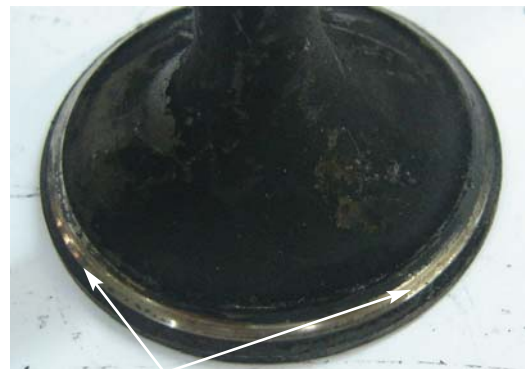
Fig. 11.9.1 Irregular seating area

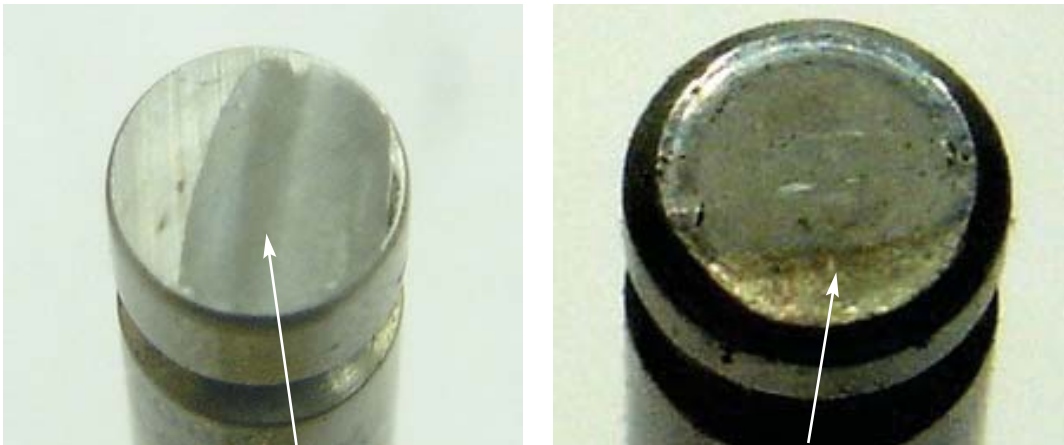
Fig. 11.9.4 Marks indicating that the valve hasn't rotated. Rocker arm deficiency
