Overview

Premature failures in pistons, piston rings, cylinder liners, bearings and bushings

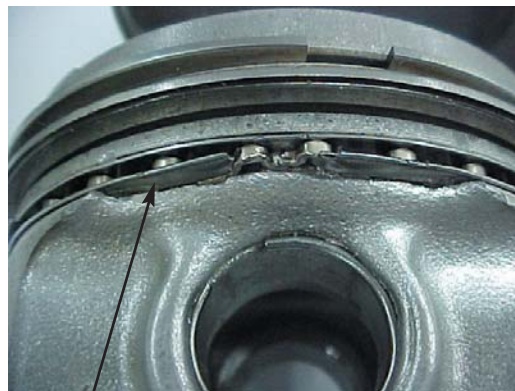
Fig. 1.1.2 Damages caused by circlip

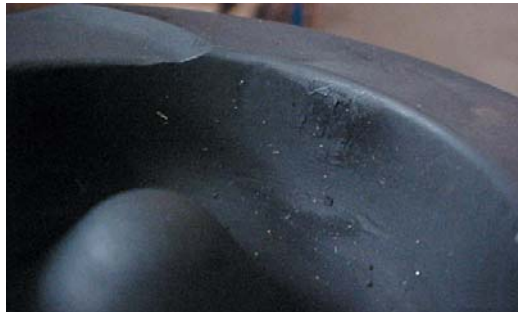
Fig. 2.6.1 Spraying occurs partially out of the combustion chamber

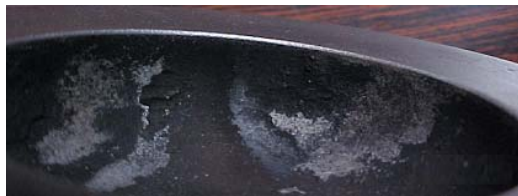
Fig. 2.6.2 Spraying occurs partially out of the combustion chamber

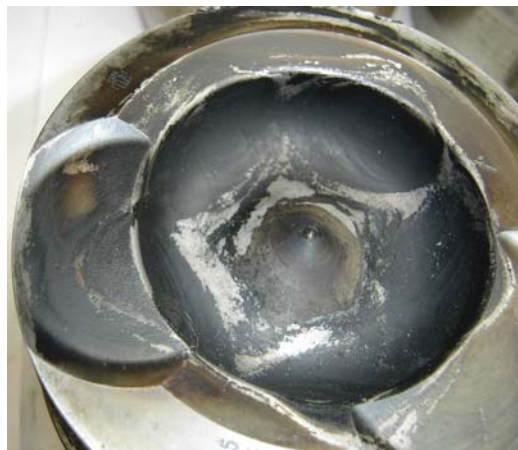
Fig. 2.6.3 Irregular spraying done by the nozzle

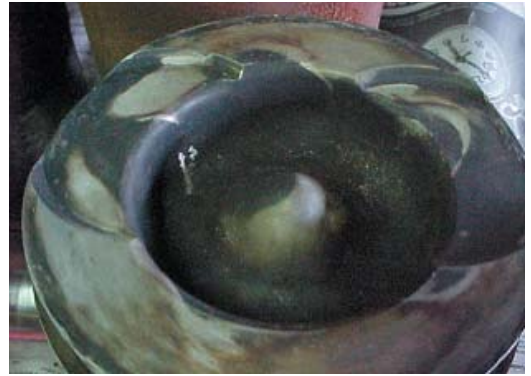
Fig. 2.6.4 Irregular spraying done by the nozzle

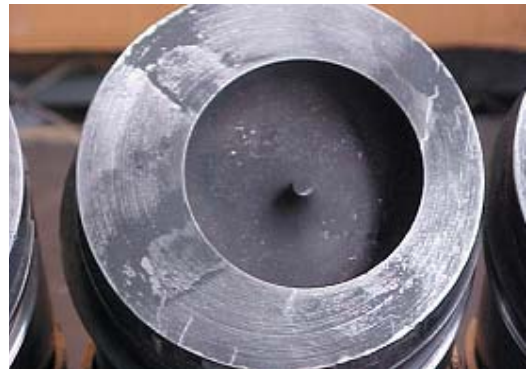
Fig. 2.6.5 Irregular spraying done by the nozzle

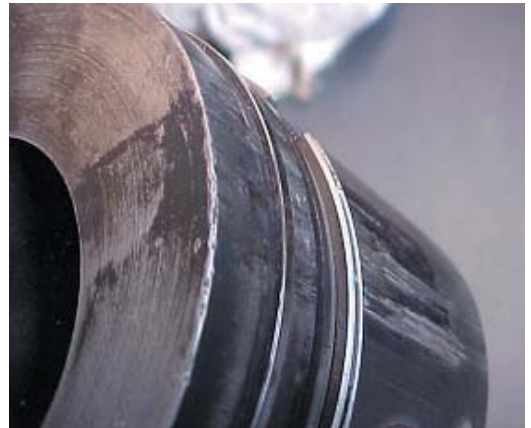
Fig. 2.6.6 Irregular spraying done by the nozzle

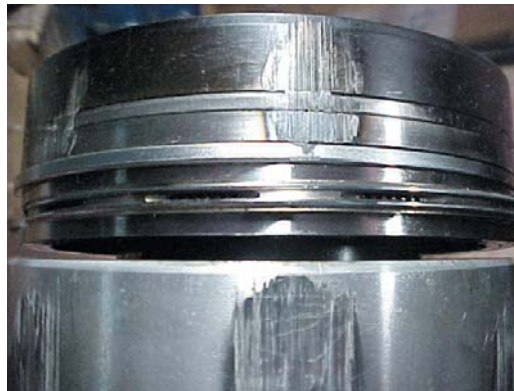
Fig. 2.7.3 Scuffing started at the top land, and extended to the piston skirt

- Regulation of injection pump and nozzles, to achieve correct injection and spraying of diesel fuel;
- Correct fuel injection point.

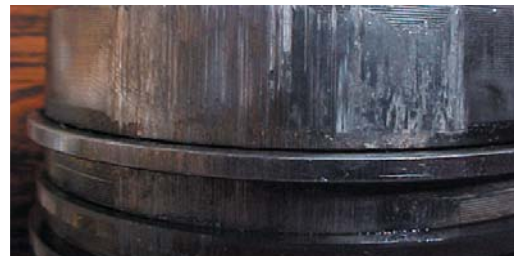
Fig. 2.7.4 Scuffing started at the top land

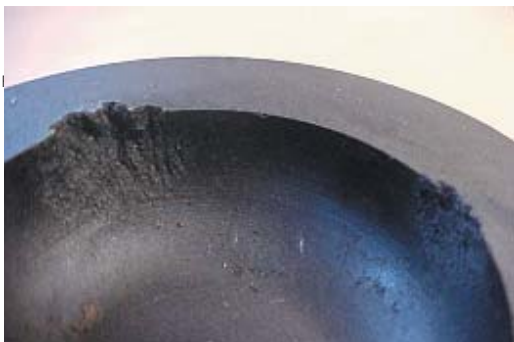
Fig. 2.7.1 Partial destruction of the combustion chamber

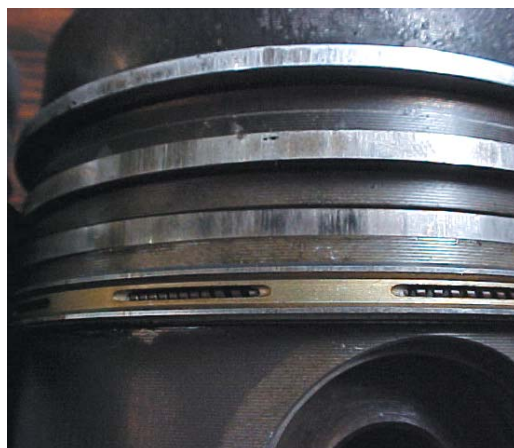
Fig. 2.7.5 Scuffing started at the top land

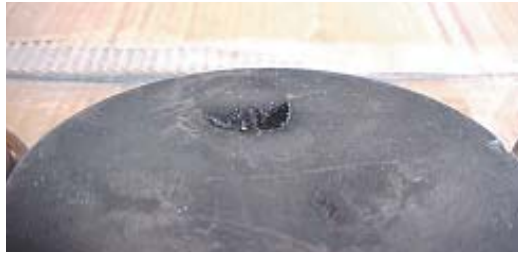
Fig. 2.7.6 Partial destruction of the crown, due to injection defect

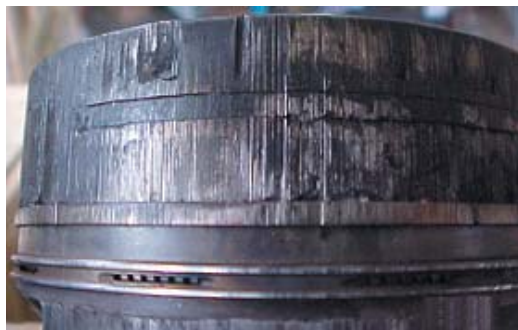
Fig. 2.7.8 Scuffing started at the top land

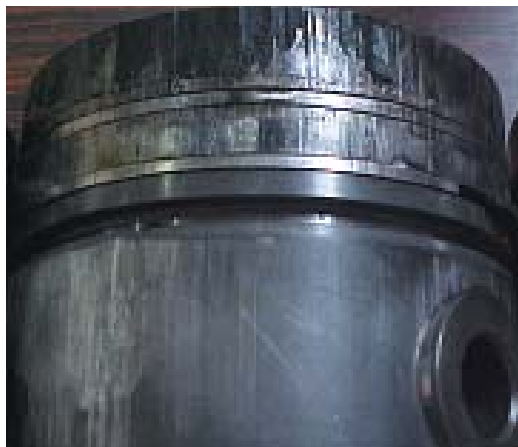
Fig. 2.7.9 Scuffing started at the top land

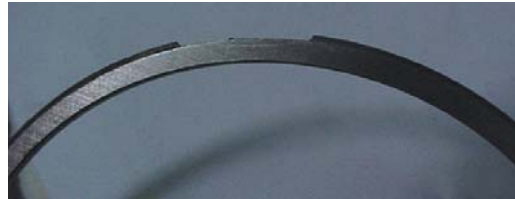
The tool used to close the piston rings when mounted on the piston, and being fitted in the cylinder, is a strap called "ring compressor". If the compressor doesn't close completely the piston rings in the groove, their side faces will collide with the cylinder edge (which should have a small chamfer to facilitate the mounting). This can result in damage or even breakage of the piston ring (see fig.3.4.2).

Fig. 3.4.2 Chipped contact face

- Don't use your hands when opening the gap ends;
- Mount the rings using adequate tools and in good working conditions, mainly the expander ring pliers;
- Use adequate ring compressor for each engine, when fitting the piston/piston ring assembly into the cylinder.

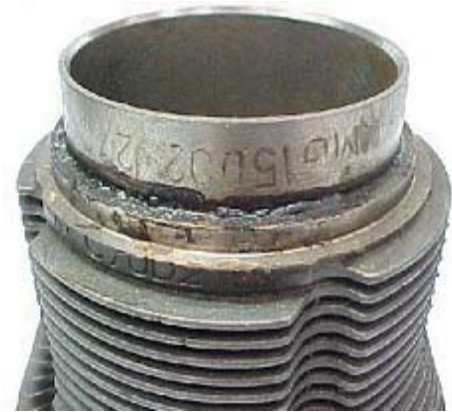
Fig. 4.1.4 Cylinder head was fitted with glue at its lower base

- Follow correctly the recommendations given by the engine manufacturer with respect of the use or no-use of glue/adhesives.

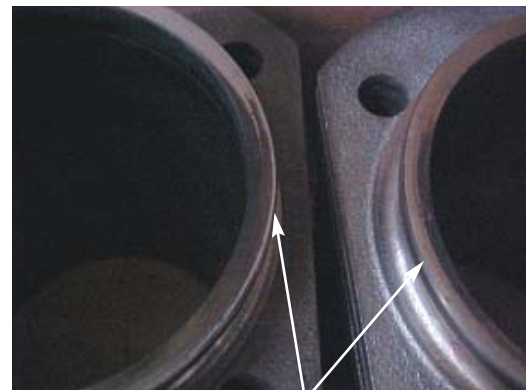
Fig. 4.1.5 Irregular cylinder liner seat on the cylinder head

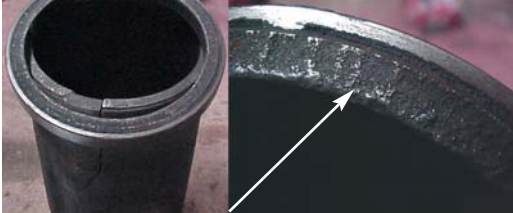
- Flange fracture of the cylinder liner and/or insufficient sealing with the cylinder head.

fastening to the engine block. In engines using dry cylinder liners, if the applied tensions happen to be higher than the ones recommended by the engine manufacturer, a flange fracture could also occur.

Figs. 5.1 and 5.1.1 Wet cylinder liner. Fractured and carbonized flange region

- Keep the dimensions of the cylinder liner seat at the engine block according to recommendations given by the manufacturer/producer;
- Follow the engine manufacturer recommendations when fitting the cylinder liners at the engine block;
- Machine correctly the cylinder liner seat at the engine block;

- Lower the cylinder head without lowering the cylinder liner housing seat depth at the head (for example: the VOLVO TD-102 FS cylinder head).

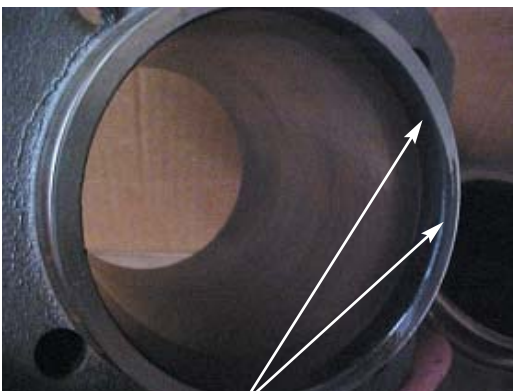
Fig. 5.1.5 Irregular seat between the upper cylinder liner part and the cylinder head

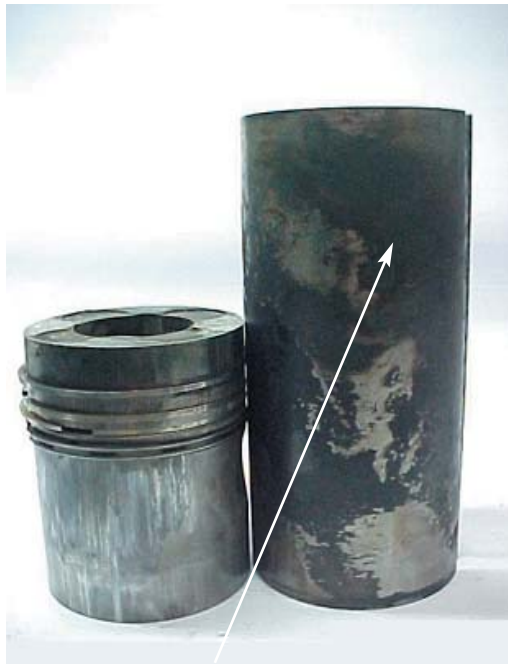
Fig. 5.2.1 Dark marks on internal side of cylinder liner, identifying the lack of interference with the housing

- After installation of the wet cylinder liner in its housing, measure the internal diameter with specific instruments and search for any cylinder liner deformation.

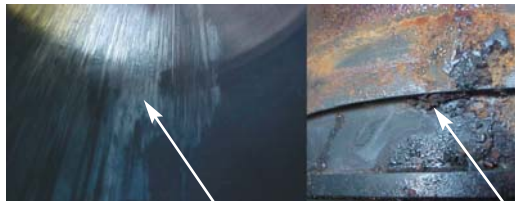
Figs. 5.2.2 and 5.2.3 Scuffing originated by O'ring displacement. Impurities in the cylinder liner O'ring housing

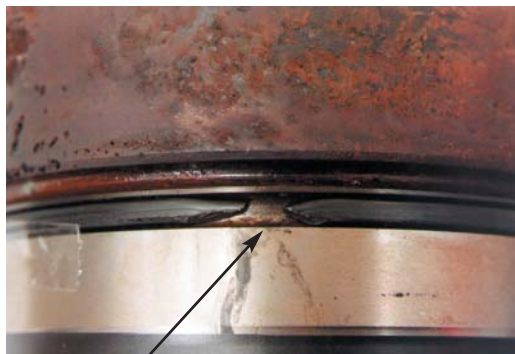
Fig. 5.2.4 O'ring has been cut during cylinder liner fitting in engine block

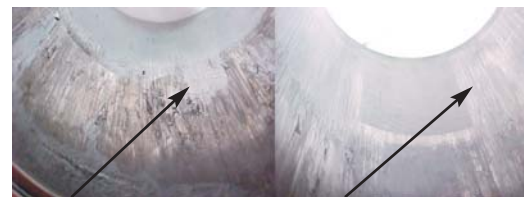
- The dilution of the lubricating oil of the inner cylinder liner wall results in a premature lapping wear done by the piston rings, and generates vertical scratches and scuffing marks, with material removal.

Figs. 5.3.1 and 5.3.2 Scuffing originated by dilution of lubricating oil existent on inner cylinder wall

- Regulate injection pump and nozzles, according to recommendations given by the engine manufacturer;
- Keep the correct injection point;
- Check the camshaft and its cams;
- Regulate correctly the carburetor;
- Apply correctly the internal components (pistons, cylinder liners and piston rings);
- Avoid constant engine speed during the running-in period.

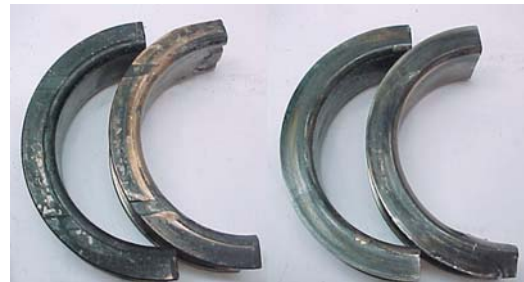
Fig. 8.1.3 Bearing flange front side without wear and back side with wear

- Obey to the assembly clearance specified by the engine manufacturer;
- Check the correct positioning of the connecting elements between engine and gear box.

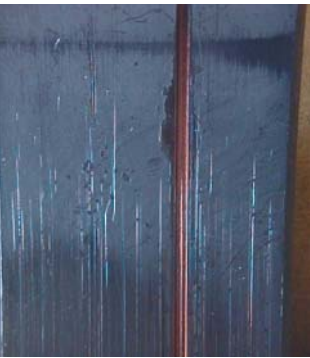
Fig. 8.2.5 Enlarged photo of a channel opened by an odd solid material, strange to the bearing

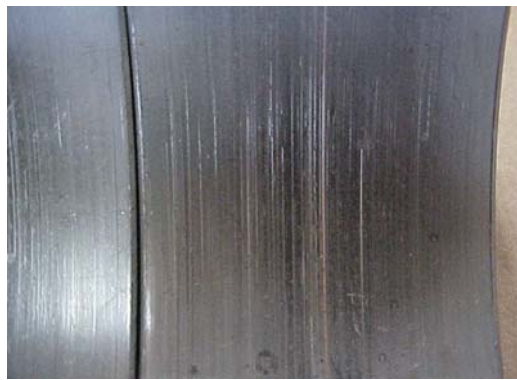
Fig. 8.2.6 Contaminated con rod bearing with circumferential scratches

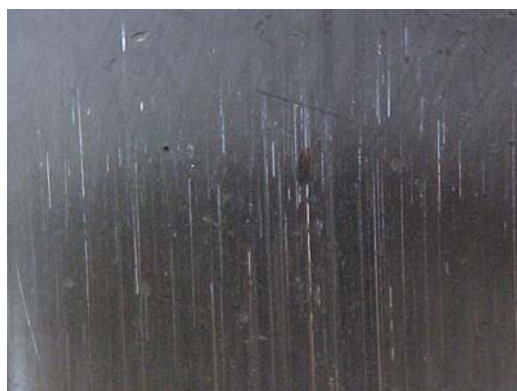
Fig. 8.2.7 Enlarged photo of scratches and odd materials on a bearing

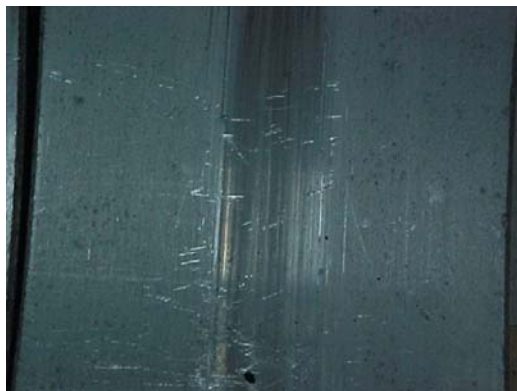
Fig. 8.2.8 Contaminated con rod bearing and circumferential scratches in the lubricating hole direction

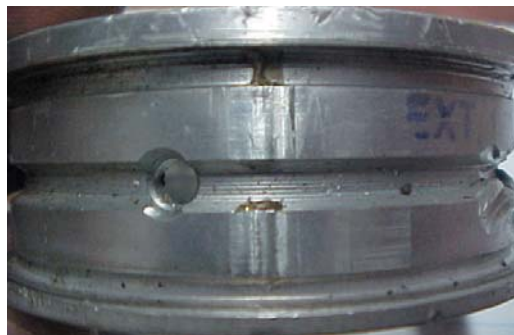
Fig. 8.13 Glue/adhesive on bearing's external lubrication channel

- The torque applied to the engine block studs/bolts, when exceeding the specification given by the engine manufacturer, tends to deformations and consequently to metal-metal contact. This contact generates sufficient heat to start the fusion and dragging of materials. Another factor leaving to fusion will be found in the partial obstruction of the external lubrication channels (fig.8.13) by glue/adhesive.

- Check/revise the wrench periodically;
- Apply the torque recommended by the engine manufacturer;
- Assemble the engine according to recommendations given by the engine manufacturer, specifically with regard to the use or no-use of glue/adhesive.

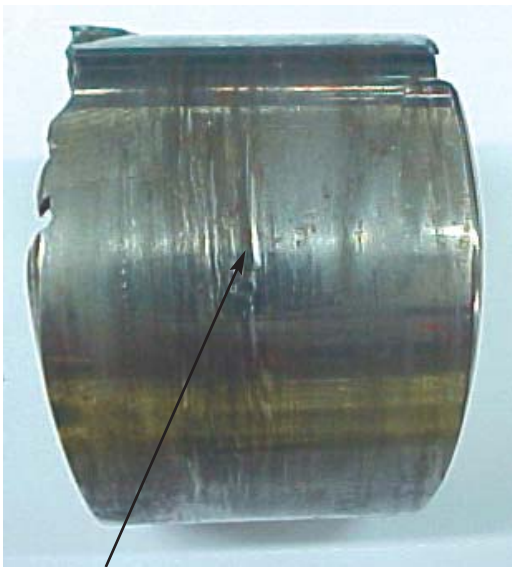
Fig. 10.3.1 Incorrect bushing mounting mark

- Use adequate tools for bushing mounting in the housing;
- Don't use deformed pieces.

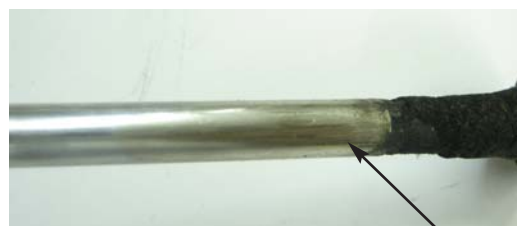
- Incorrect synchronization. The valves interference in the piston top due to incorrect synchronization, can cause bending of the stem, resulting in inadequate clearance between stem and guide. This problem can also jeopardize the sealing between the valve and the valve seat in the cylinder head (fig.11.1.3);

Fig. 11.1.3 Stem bending due to valve interference in the piston top

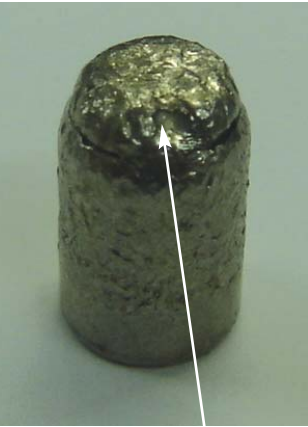
- During the valve replacement not only the springs shall be inspected and tested, as formerly informed, but also the keepers. Irregular and damaged keepers can be considered as causes of this type of failure, as well as excessive clearance during adjustment of the valves and also valve floating (fig.11.4.1, 11.4.2, 11.4.3, 11.4.4).

Fig. 11.4.1 Breakage at the keeper groove region

- Replace keepers and test the valve springs, as well as adjust correctly the valve clearance.

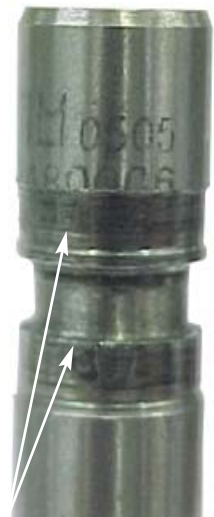
Fig. 11.4.4 Wear at the keeper groove channel caused by irregular keeper

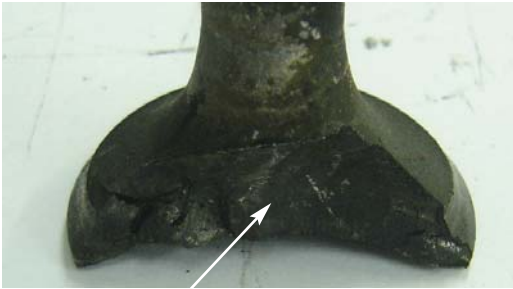
- The partial valve head breakage starts with fissures at the valve seat region and is originated by the increase of combustion pressure and temperature in the combustion chamber and at the valves. This type of failure occurs only on exhaust valves. The increase in combustion chamber and valve temperature is related to the use of inadequate fuel, incorrect ignition/injection timing, inadequate spark plugs, excessive carbon deposit and incorrectly applied valves. The incorrect bedding of the valve on its seat can be the origin of this type of fractures (fig. 11.6.1. and fig.11.6.2).

Fig. 11.6.1 Breakage of part of the head

- Keep the original characteristics of the engine, use the adequate fuel, correct ignition or injection timing, adequate spark plugs and correct the valves in relation to its seats.

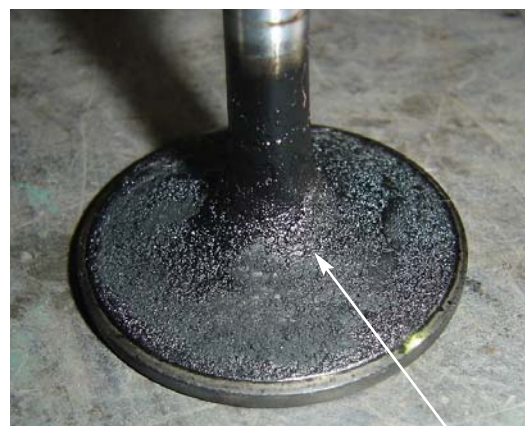
Fig. 11.9.2 Inlet valve contaminated by lubricating oil due to excessive clearance between valve and valve guide or malfunction of oil seal

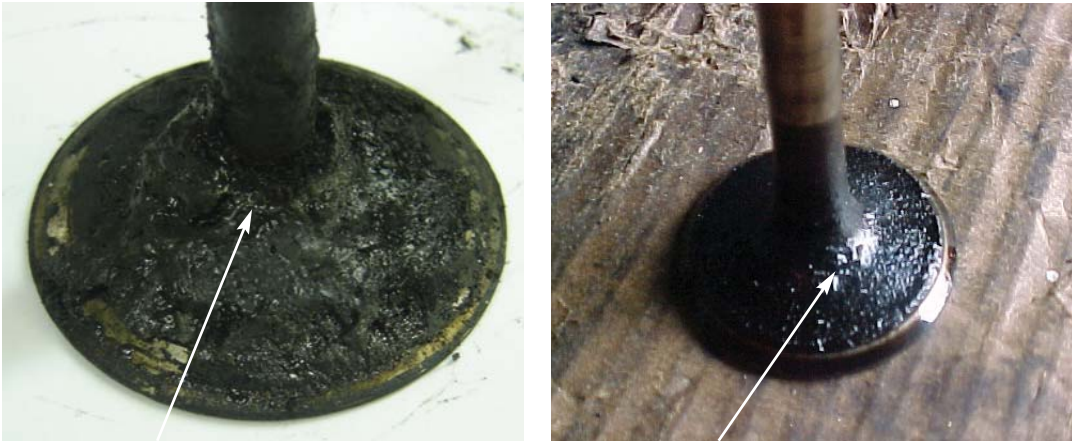
Fig. 11.9.3 Contaminated inlet valve with lubricating oil crust due to excessive clearance between valve and valve guide or malfunction of oil seal
