Overview

Premature failures in pistons, piston rings, cylinder liners, bearings and bushings

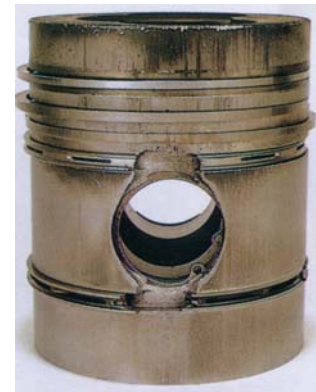
Fig. 1.1

- Breakage of the piston pin circlip groove. Generally this occurs due to a composition of forces that pushes the pin against one of the circlips, until its expulsion and/or fracture. Eventually pieces of the fractured circlip cross the inner pin diameter and damage the other end.

- Correct alignment of the con rods (changing them, if necessary);
- Cylinder rectification correctly aligned with the crankshaft;
- Correct circlip mounting, without deformations during assembly;
- Correct rectification of crankshaft journal;
- Check axial crankshaft clearance.

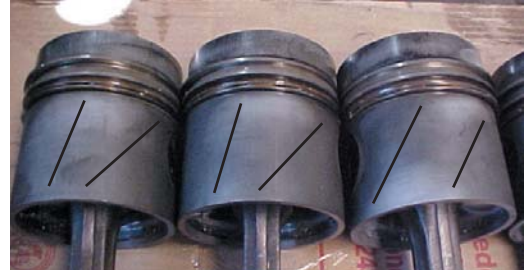
Fig. 1.3.1 Inclined marks at the piston skirt region

- Get a correct con rod alignment (changing them, if necessary);
- Rectification the cylinder, keeping it correctly aligned with the crankshaft;
- Small end bushing ID boring.

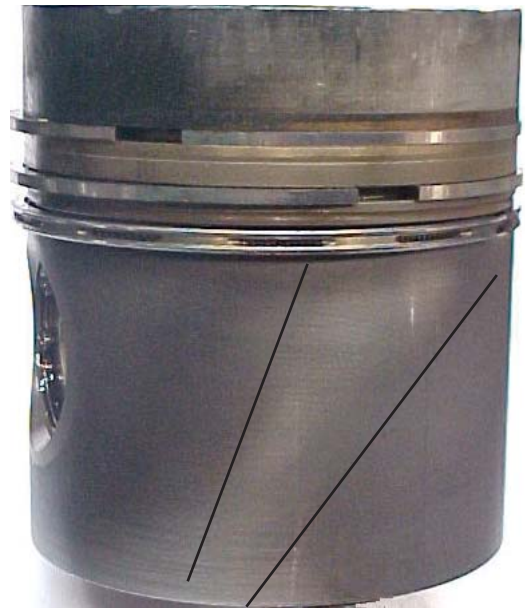
Fig. 1.3.3 Inclined marks

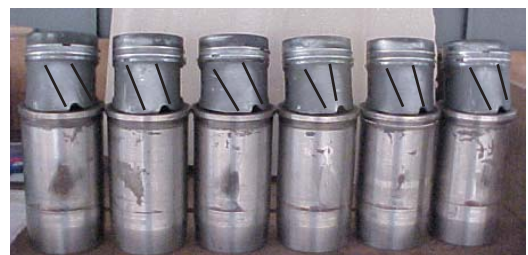
Fig. 1.3.4 Inclined marks at the piston skirt region

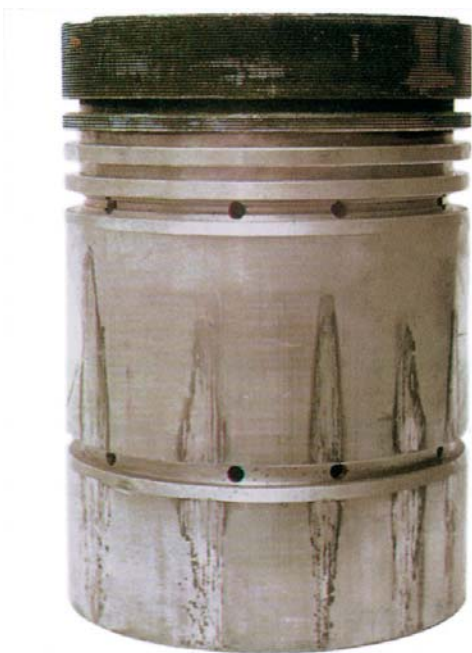
Fig. 1.4

Deformation of cylinder liners, caused by:

- Irregular engine assembly;
- Expanded o'ring seals during engine operation;
- Housing diameter of o'ring seals out of specification;
- Inadequate torque of cylinder head bolt;
- Deficient cylinder rectification.

- Provide correct machining of engine block bores for cylinder liner installation;
- Use o'ring seals of good quality;
- Verify o'ring seal housing dimensions;
- Give correct torque to cylinder head bolts.

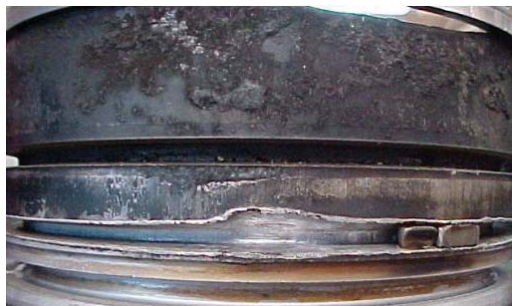
Fig. 1.5.1

The overheating of this piston region, plus the abrasion caused by the carbon materials, do result in excessive groove wear, and consequently could cause ring flutter.

- During ring changes, the groove conditions should be carefully checked, mainly the first ones, which run the compression rings;
- Keep the clearance between the rings and the grooves within the specified values.

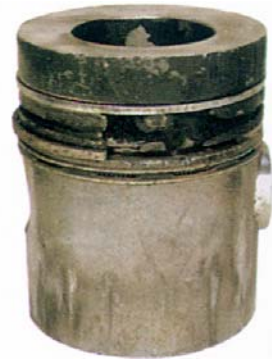
Fig. 1.5

Thus the piston has its resistance diminished, which can originate cracks that happen normally at ring lands.

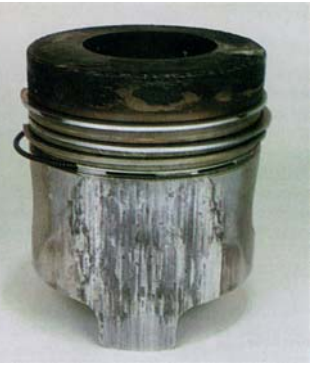
Fig. 1.6

- Considerable and generalized scuffing of the piston skirt, mainly at the thrust side, as a consequence of abnormal running, caused by a reduction of the clearance to values smaller than the ones specific in the project.

- Observe the piston/cylinder clearance recommended by the engine manufacturer.

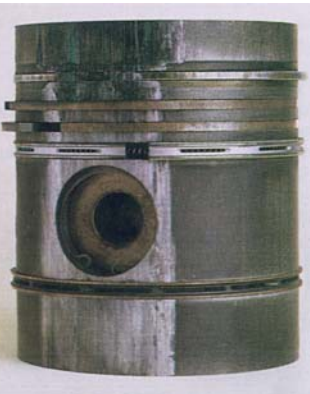
Fig. 2.1

- Excessive deposits in the engine block's water conduits, which have not been removed during the last reconditioning. These deposits cause considerable increase to the thermal resistance of the walls, increasing the piston temperature;
- The malfunction of the thermostatic valve, even during short periods, can lead to flow interruptions of the refrigerating water to the radiator, increasing therefore the engine temperature;
- Radiator in bad conditions, especially when internally or externally blocked. The thermal insulation of the radiator core from the exterior is a consequence of excessive deposits, mainly mud, at its external surface;
- A mechanical failure of the water pump can result in insufficient cooling water circulation, which is noted mainly when the engine runs at high power;
- A slack fan belt (slipping in excess),

- A faulty radiator cap doesn't offer sufficient water-sealing, and causes the fall in water pressure and frequent water "boiling";
- Draining the cooling system to remove possible air bubbles, when filling the system with additivated water.

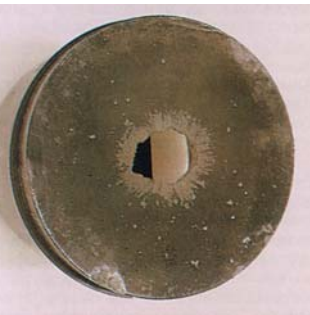
Fig. 2.3

- Incorrect spark plugs for the required service;
- Hot spots originated by defective cooling;
- Carbon deposits at very high temperatures (almost incandescent) generating hot spots;
- Valves operating at higher than normal temperatures;
- Detonation or conditions that lead to detonation.

- Installation of adequate spark plugs;
- Check the cooling system;
- De-carbonization of the piston crowns and cylinder head, whenever possible;
- Periodical regulation of engine valves, according to instructions given by the engine manufacturer.

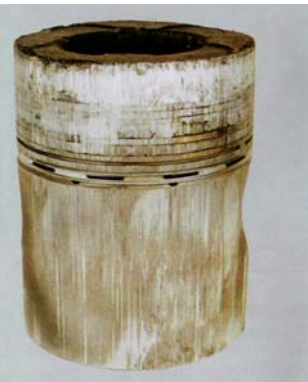
Fig. 2.6

- Scuffing stripes from piston crown downwards, generally in the direction of the diesel oil injection, tending to expand later to other regions.

- Revise periodically injection pump and nozzles, according to recommendations given by the engine manufacturer.

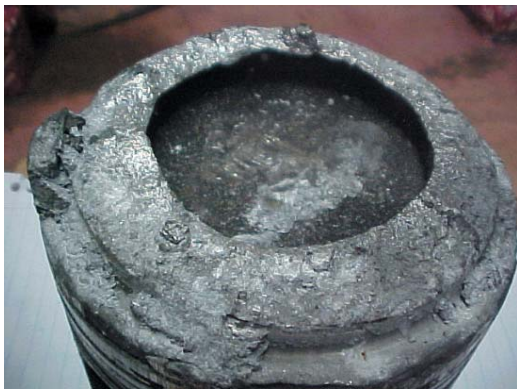
Fig. 2.7

- Excessive fuel injection at each cycle;
- Premature injection (anticipated ignition point);
- Incorrect spraying;
- Leaky injectors nozzle.

- Regulation of injection pump and nozzles, to achieve correct injection and spraying of diesel fuel;
- Correct fuel injection point.

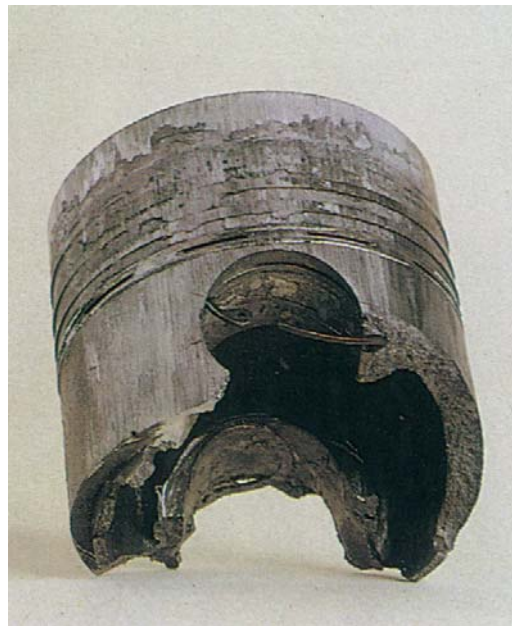
Fig. 2.9

- Deep cracks at the region of the pin bore or at the inferior skirt part, which could lead to fractures.

Normally this failure happens when running the engine under scuffing and cylinder crown seizing, caused by:

- Incorrect clearance when fitting piston/cylinders;
- Engine overload during running-in period;
- Insufficient cooling;
- Insufficient lubrication;
- Abnormal combustion.

When the scuffed piston is moved-on by the other ones, its skirt is torn out, starting at the middle section of the pin bore.

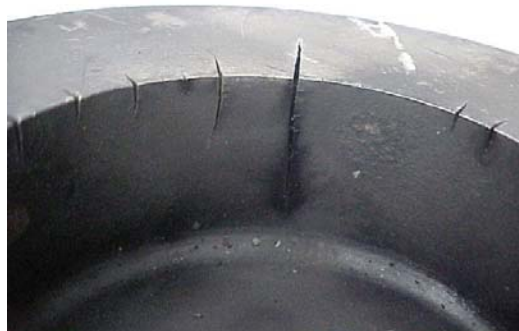
Fig. 2.10.1

- Radial cracks starting at the bowl rim of the piston of diesel engines with direct injection.

- The elasticity limit of the piston material is low and therefore is easily exceeded at high temperatures. A plastic deformation occurs in form of accumulated material or its concentration on the combustion chamber's periphery;
- Once the piston cools down to ambient temperature, the deformation persists, resulting in tensile stresses, which lead to cracks at the combustion chamber corners.

- Increase of compression ratio, to values that are higher than the limits given in the project;
- Increase of engine speed, surpassing the limits given by the engine manufacturer;
- Inadequate fuel for the existing compression ratio;
- Inverted piston assembly;
- Excessive piston/cylinder clearance.

- Keep the compression ratio and the speed specified by the engine manufacturer;
- Use adequate fuel for the existing compression ratio;
- Observe the piston/cylinder clearance specified by the engine manufacturer;
- Observe the fitting instructions indicated on the piston crown.

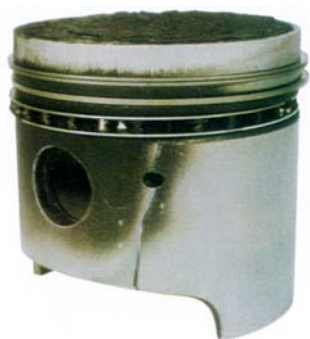
Fig. 2.11

- In some piston types a crack at the skirt starts at the hole of the oil groove slot and in others, at the slot existing in the skirt.

This type of crack is characteristic in cases of engine overload and, consequently, overload of the piston. Generally it occurs at the high-pressure side (thrust side), because the most loaded region is the skirt, which in this case is submitted to excessive flexion.

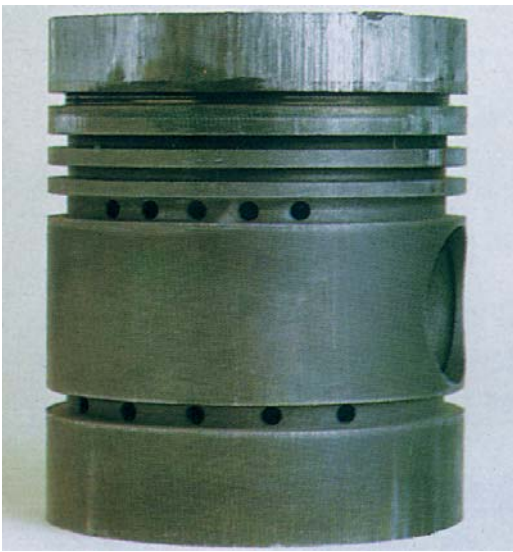
Fig. 2.12

The deformation of the upper cylinder part results in damage of the piston's top land. The causes of this type of piston wear can be:

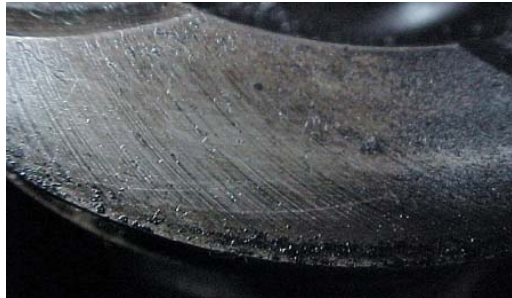
- Cracks originated along the combustion bowl rim;
- The piston crown shows machining tool marks and absence of piece identification marks.

- The machining of the piston crown reduces the distance between the first ring groove and the crown (top land height reduction). This reduction, plus the withdrawal of the concordance of the combustion chamber edges radii, results in an increase in piston crown tensions, increase in concentration of tensions at said combustion bowl rim and, consequently, increase in susceptibility for cracks in this region (see fig. 2.13.6).

Fig. 2.13 Machined crown

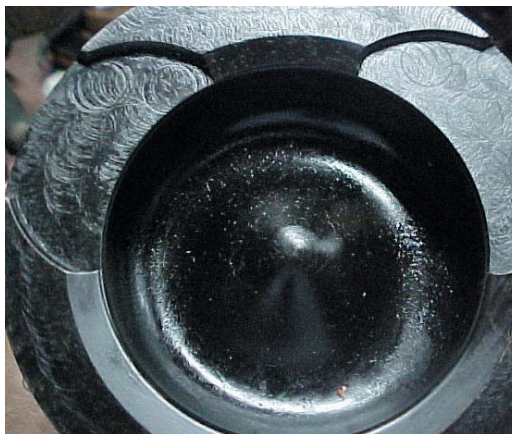
Fig. 2.13.2 Machining marks on piston crown and valve recesses

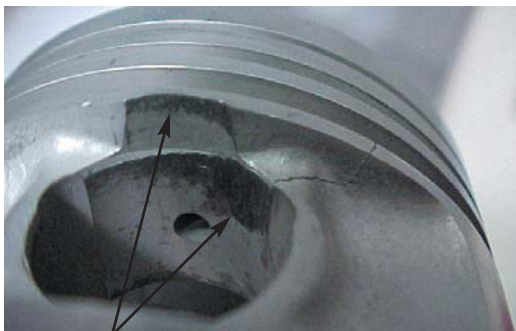
- The part presents irregular marks on the piston pin, as a result of overheating. The piston also can present: cracks/fractures at the pin boss region, lubricating oil consumption, aligned ring end gaps and noises.

Fig. 2.14.2 Irregular piston pin marks on the bosses during con rod fitting

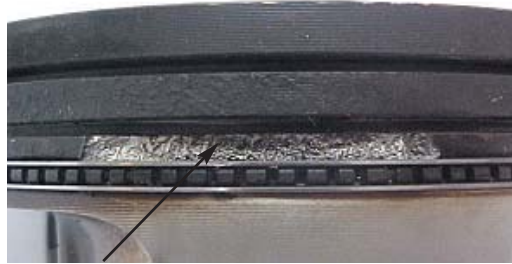
- Diesel and Otto-cycle pistons present rupture/breakage at first and/or second land between ring grooves.

a consequence of a sudden combustion pressure peak. This occurs due to the an increase in admitted fuel volume/mass, due to the decrease in combustion chamber volume in the cylinder head and also due to an incorrect injection/ignition point. Under these conditions the piston is submitted to an increase in mechanical and thermal loads (higher peak pressure), causing the rupture of the lands between the ring grooves. This rupture/ breakage is related to the process called "DETONATION".

Fig. 2.15.1 Broken land in piston (Otto-cycle engine)

- Keep the cylinder head height according to recommendations given by the engine manufacturer;
- Keep the engine block height according to the recommendations given by the engine manufacturer;
- Keep the projection of the piston in relation to the engine block according to the recommendations given by the engine manufacturer;
- Don't use fuel of bad quality;
- Revise peripheral engine component (injection pump and nozzles, cold start system, starting motor and battery);
- Use heating spark plug correctly (if existent);
- Apply the parts and the components correctly;
- Use correct injection point;
- Check items which could lead to "DETONATION".

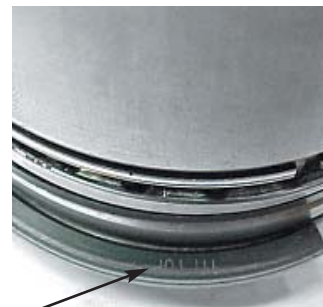
- Wrong/inverted mounting of the piston rings in the piston grooves (fig.3.1 and 3.1.1). When this happens, the piston rings don't perform as expected, allowing the combustion chamber gases to leak easily to the carter, forming consequently an irregular air/fuel mixture to be admitted to the combustion chamber. The lubricating oil temperature and the carter pressure increase. Furthermore the inverted mounting of the piston rings increases the lubricating oil consumption, because instead of scraping the oil down, the piston rings will pump it up, to be burnt together with the air/fuel mixture

Fig. 3.1.1 Piston ring mark mounted towards the lower side

- Replace the ring set and fit the new one with its markings directed to the piston crown.

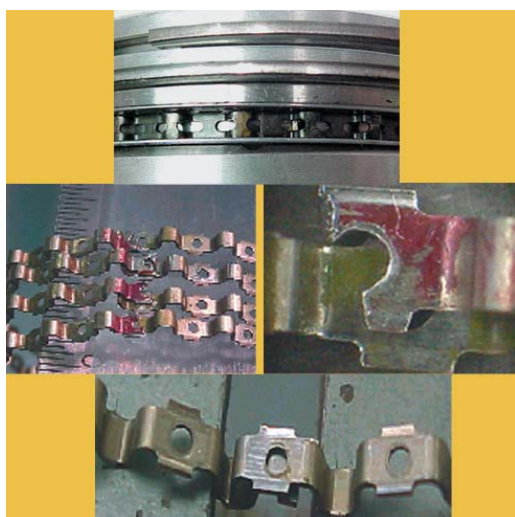
Fig. 3.2.1

- The mounting of overlapped coil spring (fig.3.2) or expander (fig.3.2.1) ends during the oil ring assembly affects the radial piston ring pressure, and consequently its function, which is to control the excess in lubricating oil of the cylinder walls. This radial pressure reduction will result in a considerable increase in oil consumption.

- The spring-ends of a 2-piece oil ring have to be mounted at 180° from the gap. The overlapping of the expander ends in a 3-piece oil ring should by all means be avoided.

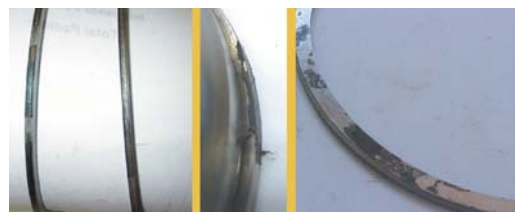
Fig. 3.3

impregnated at its running and side surfaces (fig.3.3).

- The piston ring contamination by odd material occurred during the engine assembly. The use of adhesives for engine sealing, close to the cylinders, is a procedure which no manufacturer/producer recommends. In this case the contaminated piston rings had its sealing function reduced, because the pressure at the periphery has been unevenly distributed, due to the "wedge" provided by the adhesive. This reduces the operational life of the piston rings, causing an increase in lubricating oil consumption and irregular wear at the cylinders.

- Mounting has to be done according to recommendations given by the engine manufacturer;
- Clean all internal components with materials void of dirt and impurities, by using the adequate procedure.

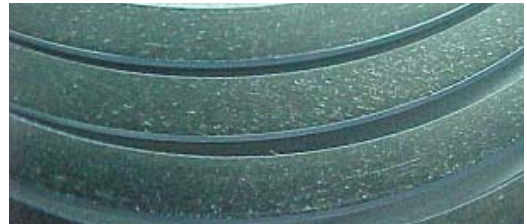
- The piston rings present scratches and premature wear at the running face (fig.3.5.1, 3.5.2, 3.5.3, 3.5.6 and 3.5.7), as well as on side faces (fig.3.5.4 and 3.5.5). The oil rings present a large and plain running face (in some cases even inexistent).

- Solid particles of different sizes are present in the air. These particles, such as sand (silica), dust, carbon, among others, when aspirated by the engine, cause serious damage to the piston rings, resulting in: premature wear of the coating on the running and side faces, reduction in radial thickness, increase in gap clearance, pressure reduction and deep scratches on the cylinders and on the piston skirt.

Fig. 3.5.5 Piston ring with abrasive particles on lateral face

- Use only filters according to the recommended applications, verify them and change them according to recommendations given by the engine/vehicle manufacturer;
- Make a periodical check-up of the filter system (hoses, clamps, seals, etc);
- Prepare and clean correctly the internal components before assembling them on the engine;
- Use fuel of good quality, as well as correct filter elements and separation filters.

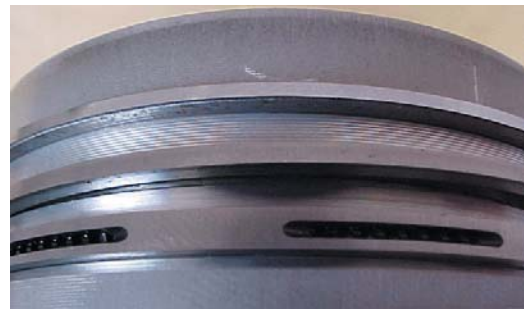
Fig. 3.5.6 Worn-out piston ring of the third groove

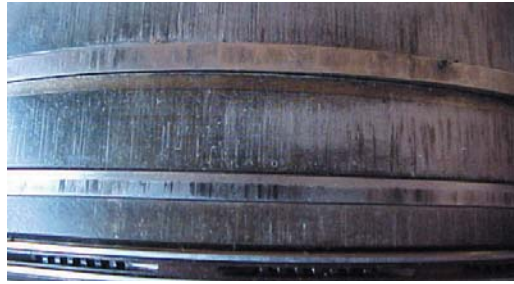
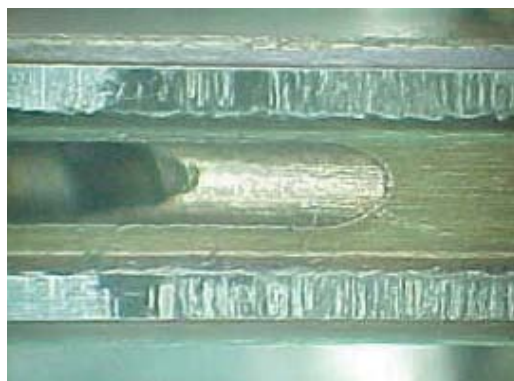
- The rings present scuffing signals on the running surface (fig.3.6.1 to 3.6.5).

- **Injection system and/or carburetion deficiencies** - the main causes for the cylinder washing are connected to an incorrect regulation of the injection pump and nozzles, resulting in a series of changes: quantity of delivered diesel fuel, injection-pump rotation, synchronization between governor and pump, synchronization among pump elements, opening pressure and projection of the injection nozzles out of recommendation, and the height of the piston crown, in case of Diesel-cycle engines. For the Otto-cycle engines the "big villain" is the carburetor with bad application and/or regulation. All of this will wash the lubricating oil from the cylinder walls. Both the Diesel and the Otto-cycle engines, in presence of insufficient oil lubrication of the cylinders, will increase the friction and the heating of the piston rings, which can result in flaking-off (fig.3.6.5) and can initiate a scuffing process, seizing of the cylinders, or also can wear the cylinders in excess;

- **Lubricating system deficiencies** - a worn-out lubricating oil pump will reduce its pumping capacity, having as a consequence, the reduction in pressure in the oil circuit, and jeopardizing the engine lubrication, originating in this way the above-mentioned damages.

- Keep the injection system and the carburetor always regulated, following the recommendations given by the manufacturer/producer;
- Check periodically the engine oil lubricating system;
- Check and maintain the original turbine.

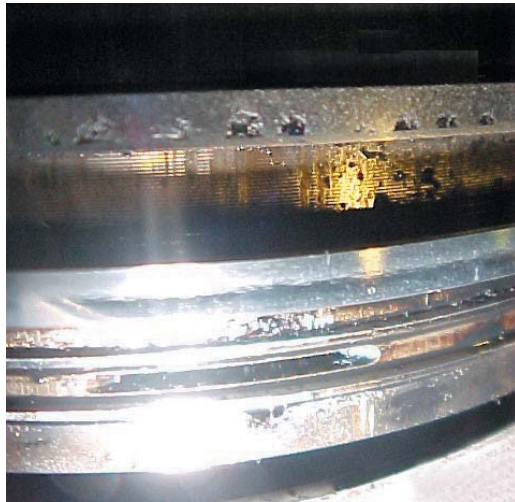
Fig. 3.6.5 Flaking-off of the piston ring coating

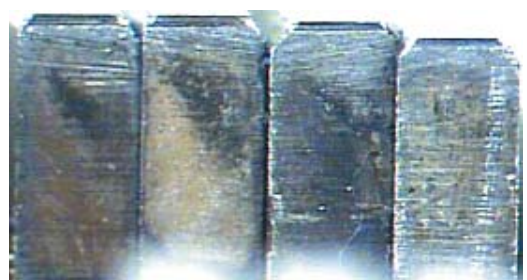
- The reworking of the piston ring butt ends is done to reduce its external diameters and to adapt them for different applications than the ones for which they have been recommended by the engine manufacturer. The change in the constructive characteristics of piston rings is not recommended by MAHLE and cancels any product warranty.

Adulterated butts - ground, eliminating external chamfer/irregular finish

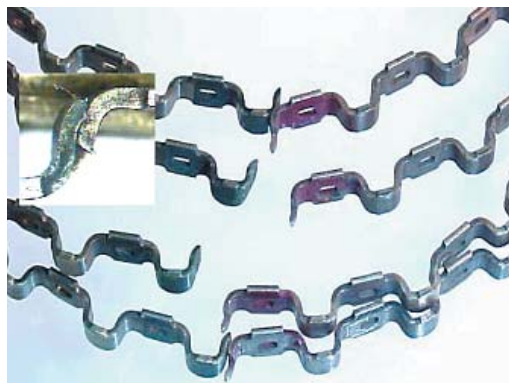
Fig. 3.7.2.8 Adulteration on one of the ends

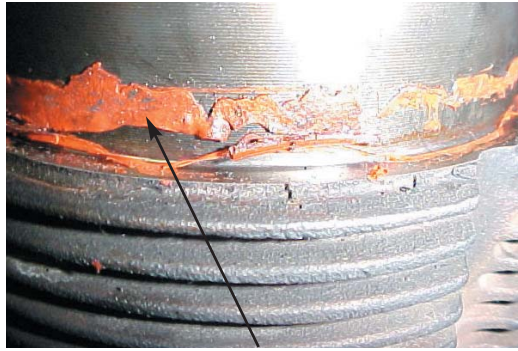
Fig. 4.1.2 Silicone at the lower base of the cylinder liner

- Follow correctly the recommendations given by the engine manufacturer with respect of the use or no-use of glue/adhesives.

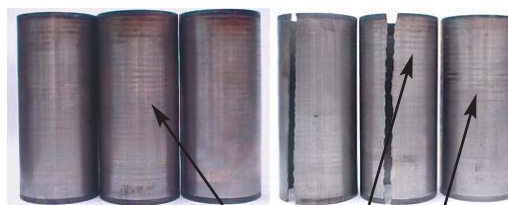
In engines running with **wet cylinder liners**, irregularities on the engine block housing, O-rings and even the displacement of these rings during the fitting of the cylinder liner, can cause:

- Change in clearance between the piston and the cylinder liner, due to deformations, with possible scuffing originated by the displacement of material from the piston skirt region, at the area where the O-rings are installed in the engine block. Scuffing could expand later to the piston ring region. If necessary, remove the cylinder liner and re-install it, eliminating excessive deformations.

Fig. 5.2 cylinder liners with machining marks from engine block

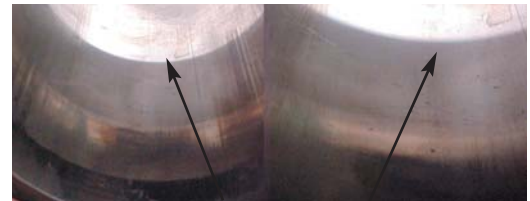
- Incorrect injection pump and nozzle regulation;
- Turbo charger ;
- Incorrect projection of the injection nozzles, in relation to the cylinder head;
- Incorrect injection/ignition points;
- Bent camshaft or with defect cams;
- Incorrect carburetor regulation;
- Incorrect engine running-in period.

Fig. 5.3 Cylinder liner with bore polishing, due to constant speed

- Regulate injection pump and nozzles, according to recommendations given by the engine manufacturer;
- Keep the correct injection point;
- Check the camshaft and its cams;
- Regulate correctly the carburetor;
- Apply correctly the internal components (pistons, cylinder liners and piston rings);
- Avoid constant engine speed during the running-in period.

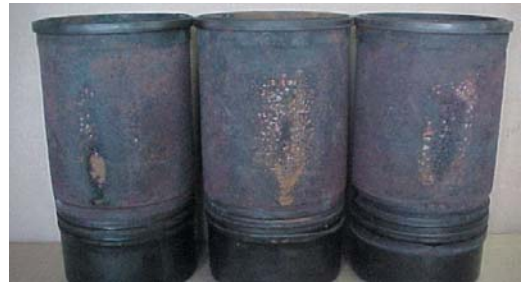
- **Cavitation** - During the engine running, the cylinder liners are submitted to pulsations, which are the consequence of the air/fuel combustion in its interior. When the combustion occurs, the cylinder wall expands fractions of a millimeter, due to the pressure of the expanding gases against the inner walls. Once the gas expansion is over, the cylinder walls return to its normal dimensions. This return happens in a very small space of time; the cooling water has not sufficient time to fill the resulting space, and originates very small vacuum bubbles, which implode against the cylinder wall, tearing off small particles and at the end perforating it.

Fig. 6.1.5 Cavitation

- Keep all cooling system components (reservoir and/or radiator cap, hoses and clamps, thermostatic and pressostatic valves, water pump, etc.) in normal running conditions, compatible with the engine project;
- Always use the corrosion inhibitor additives and the anti-freezing fluids, as recommended by the manufacturer/producer of the engine;
- Keep the correct water level in the reservoir and/or radiator. When there is a refilling need in the water system, follow the recommendations given by the engine manufacturer, with regard to quantity of additives to be used;
- Assemble the engine according to recommendations given by the manufacturer/producer with regard to eventual changes in pistons, injection system or any other.

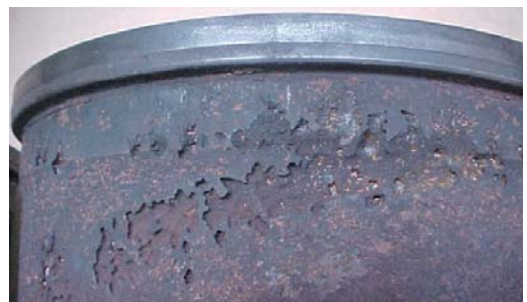
Fig. 6.1.6 Cavitation

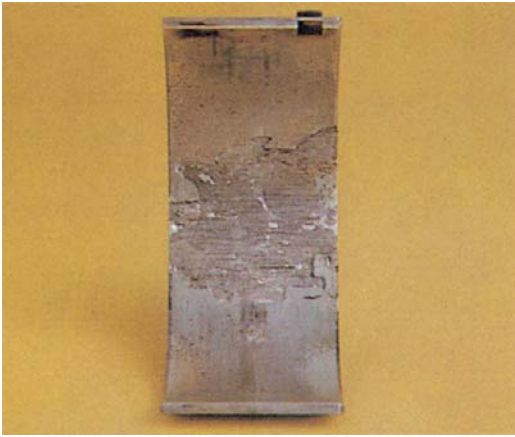
Fig. 7.3

- Fatigue damages can be caused by abnormal and cyclical stresses, in other words, by load peaks (fig. 7.3.1).

Fatigue fractures are initiated by excessive loads, and have a perpendicular propagation to the bearing surface. Before reaching the bonding line between the bearing alloy and the support material (steel), the fracture changes its direction, propagating itself parallel to the bonding line.

- If the bearing's operational life has been lower than expected, check the temperature and load conditions in which the engine has been running, and eliminate eventual existing defects;
- Avoid operational engine over-loads, observing the recommendations given by the engine manufacturer.

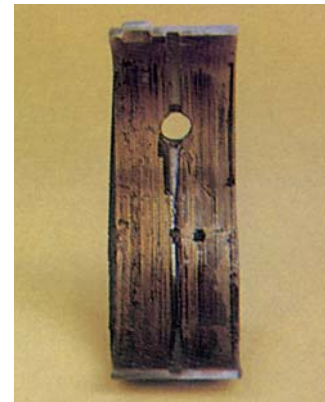
Fig. 7.4

- When a bearing fails because of insufficient or diluted lubricating oil, its running surface can get shiny (fig. 7.4.2). In the case of complete lack of lubrication, the bearing will present excessive wear by dragging off material along the axle, at the contact zone of the bearing sliding surface, with the journals of the crankshaft.

Insufficient or diluted lubricating oil film between the bearing and the axle, will wear the electrodeposited layer. It is normally caused by:

- Check the oil pump and relieve valve's running conditions. Recondition or change them, if necessary;
- Check if the bearing oil holes are in-line with the corresponding holes on the engine block and con rods;
- Avoid engine running at low speed for long periods;
- Check de dilution of lubricating oil by the fuel or the cooling liquid.

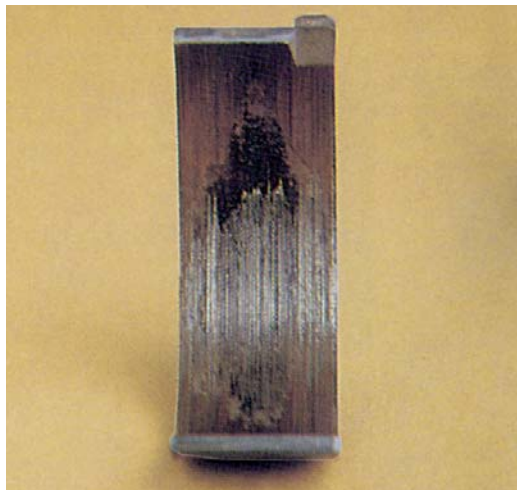
Fig. 7.4.1

The lack of lubricating oil leads to metal-metal contact between the bearing and the crankshaft journal, and to excessive wear, due to dragging away of anti-friction material. It is normally caused by:

- Partially clogged oil galleries;
- Incorrect choice of bearing under-size;
- Inverted mounting of the main bearings (lower part versus upper part);
- Bad functioning of the oil pump or the relieve valve.

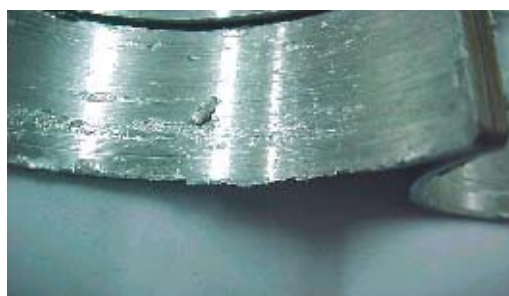
dynamic support to the axle. This results in a contact between the axle and the bearing surface, causing fusion and surface deformation of the bearing's anti-friction alloy (figs. 7.6 to 7.6.3).

Fig. 7.6.2 Yield of material

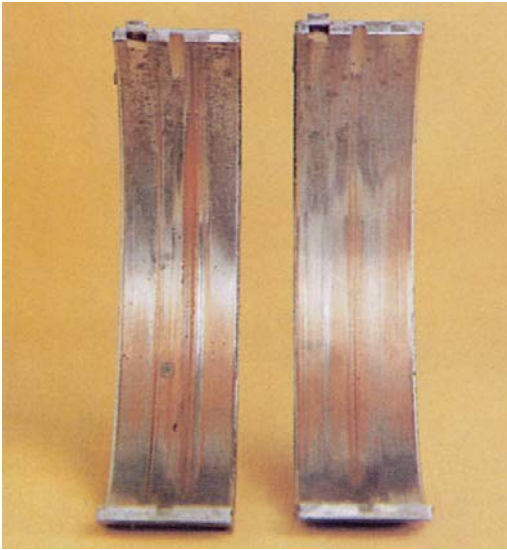
Fig. 8.2

- Foreign particles get imbedded in the anti-friction alloy, resulting in material displacement. Scratches on the bearing surface can also be found.

- Dust, dirt, abrasives and metallic particles, present in the oil, are absorbed on the bearing surface, displacing the anti-friction alloy. The projection of this alloy or these particles can touch the axle, creating local friction points and disrupting the oil film (fig.8.2.3).

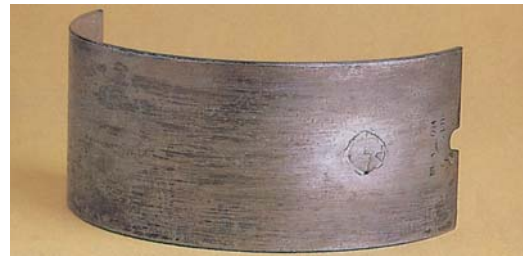
Fig. 8.3.1

- Localized worn areas at the alloy's surface, corresponding to a mark caused by the presence of odd particles at the bearing back.

- Clean carefully the housing, eliminating all burrs, dirt and solid particles, before installing new bearings;
- Check the crankshaft journal and grinding them, if necessary.

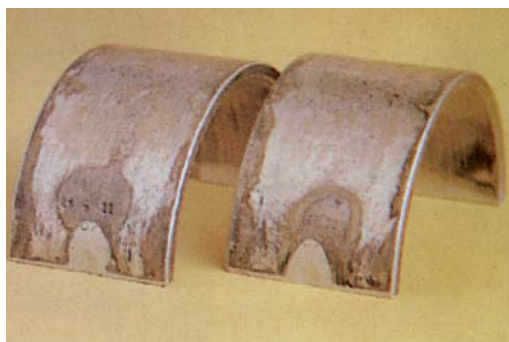
Fig. 8.5.1

With inadequate contact, the heat flow gets difficult, and at the same time the additional friction caused by the bearing pulsation, increases the generated heat (fig. 8.5.3). The causes for an insufficient part line height:

- Clean the part line surfaces before fastening nuts and bolts;
- Check housing dimensions and general conditions, boring it, if necessary;
- When fastening nuts and bolts, apply the torque recommended by the engine manufacturer.

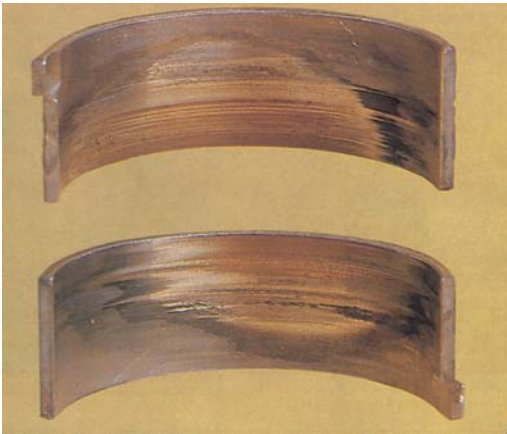
Fig. 8.7

- Excessively worn-out areas on diagonally opposed sides of each bearing.

- In a bent or twisted con rod, the housings are misaligned, originating areas of high pressure and even metal-metal contacts between the bearing and the crankshaft journal. Con rod bending can be caused by forced fitting of the piston pin, by fastening of the cap bolts while the con rod is fixed incorrectly on the vise, or by hydraulic rock (fig. 8.7.1).

- Check the con rod and replace it, if necessary;
- Avoid torsion loads on the con rod.

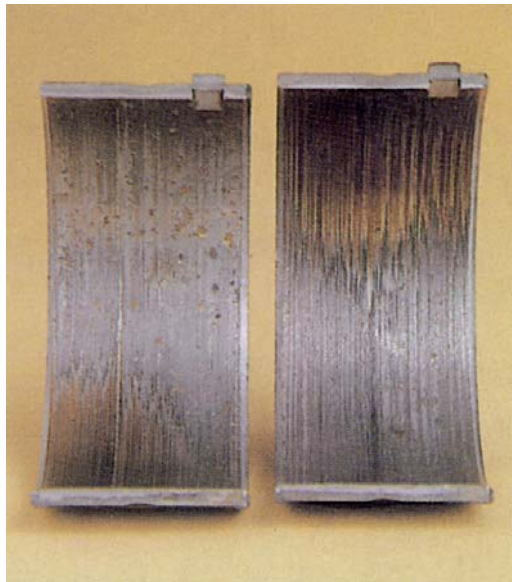
Fig. 8.8.1

- Areas with excessive wear on diagonally opposed sides of each bearing, close to the part line surface.

The bearing cap was displaced, forcing one side of each bearing against the camshaft (fig. 8.8). This can happen, due to following causes:

- Choose adequate wrench and fasten bolts alternatively in order to get a perfect cap seating;
- Be sure the cap position is correct;
- Check if the cap centralizing system is not altered nor damaged, and replace it, if necessary;
- Replace the con rod and/or housing bolts according to the recommendations given by the engine manufacturer;
- Machine the crankshaft according to specifications given by the engine manufacturer.

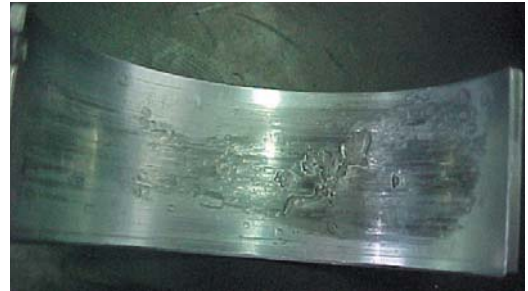
Fig. 8.8.3 Premature wear

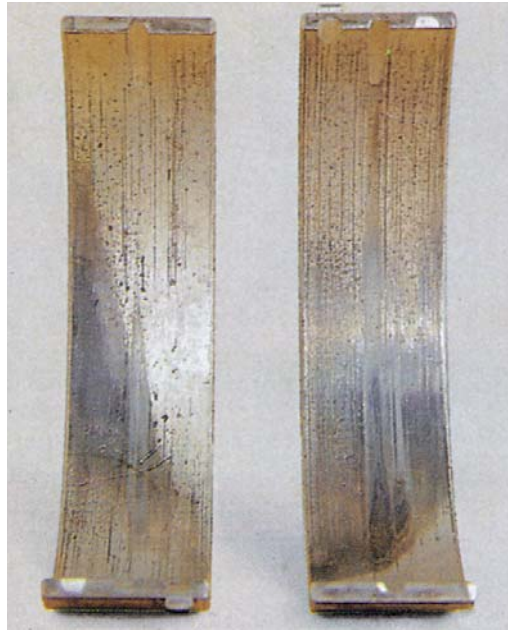
Fig. 8.10

■ A well-defined wear strip can be observed at the upper or at the under main bearing set. The extension of this wear can change from bearing to bearing, but in general it is more accentuated at the center bearing.

The sudden heating and cooling of the engine is one of the causes for engine distortion, when it operates without thermostatic valve. The engine block deformation can also be caused by:

- Check for the existence of deformations, by an adequate process;
- Bore the main housing;
- Install a thermostatic valve.

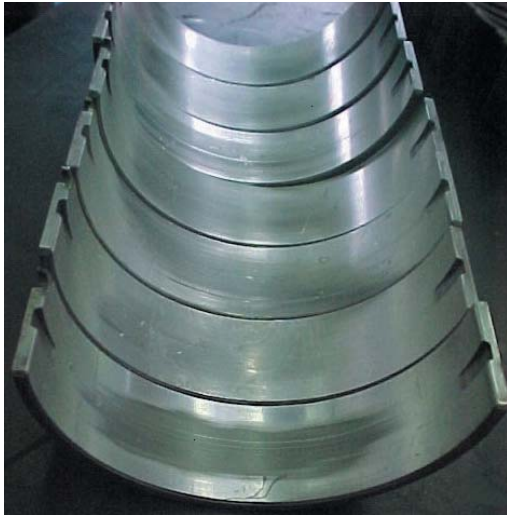
Fig. 8.10.3 Irregular bearings marks

- Grind correctly the crankshaft journals and the housings.

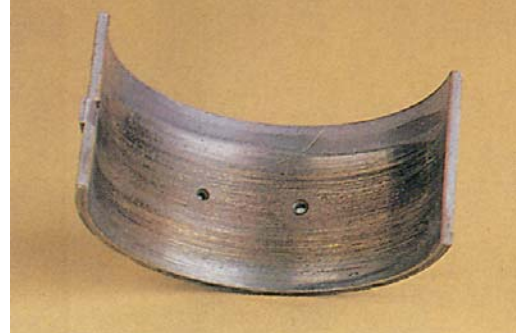
Fig. 8.11.1

- Unequal wear strip on bearing. Depending on the regions where the highest pressures have been active, three main aspects can be distinguished, which correspond respectively to form defects of the illustrated crankshaft journal (fig. 8.11 - A, B and C).

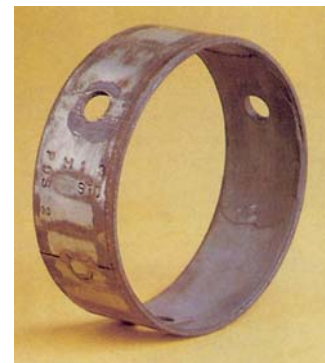
Fig. 10.2

Should the housing form tolerances not comply with the tolerances given by the engine

manufacturer, the contact area between the bushing and the housing will be reduced, resulting in a bad seating of the bushing. This doesn't allow a good dissipation of the heat generated by the bearing operation, and can result in a fusion of the bushing alloy. It can also result in a form error on the internal diameter, after the bushing has been fitted, interrupting the lubricating oil film and consequently causing fatigue, scuffing and material detachment.

- Check the housing circularity before mounting a new bushing;
- In the case of a highly deformed housing, rectify it and use bushings with external oversize;
- Keep the clearance and interference specifications between the bushing and the housing, as recommended by the engine manufacturer.

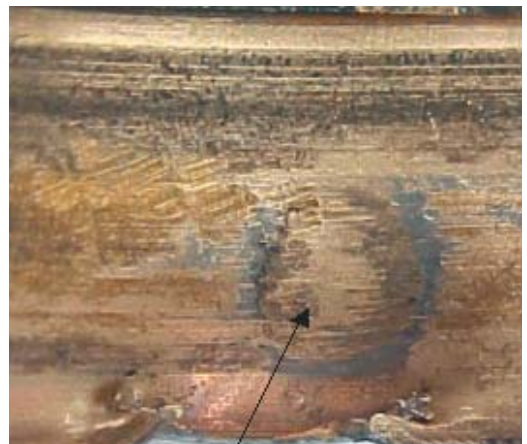
Fig. 10.2.5 Internal mark formed by odd material

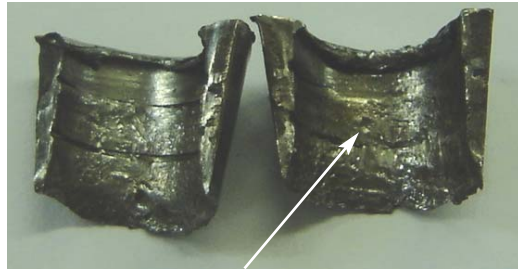
- During the valve replacement not only the springs shall be inspected and tested, as formerly informed, but also the keepers. Irregular and damaged keepers can be considered as causes of this type of failure, as well as excessive clearance during adjustment of the valves and also valve floating (fig.11.4.1, 11.4.2, 11.4.3, 11.4.4).

Fig. 11.4.2 Damaged keeper

- Replace keepers and test the valve springs, as well as adjust correctly the valve clearance.

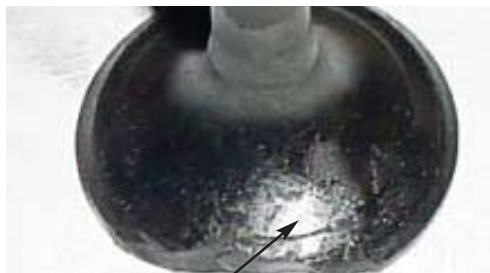
- The start of the fissure is given by a thermal shock caused by unequal heating, which results in thermal fatigue. Misalignment between valve steam and valve seat and insufficient contact (valve/valve seat) lead to inadequate cooling. The incorrect operation of the vehicle, as well as the use of uncoupling during descents (gear box in the neutral position) also contribute to thermal fatigue (fig. 11.5.1 and 11.5.2).

Fig. 11.5.1 Broken head

- Correct the alignment of valve steam and valve seat, seat sealing (valve and valve seat) as well as operate the vehicle according to the manufacturer's recommendations.

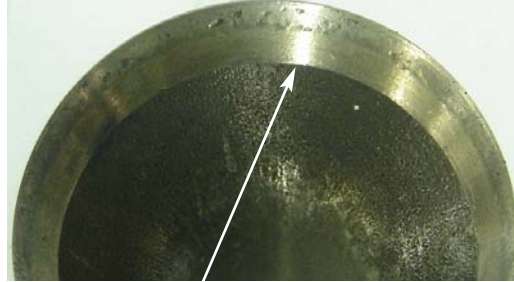
Fig. 11.7.2 Wear at the valve head region

- Wear is related to the increase in valve closing forces, combined with high operational temperatures and combustion pressures. Pre-ignition, detonation, poor fuel mixture and inadequate compression ratio are factors that affect and wear the valve head (fig. 11.7.1.and 11.7.2).
